Could your 1963-1980 Avanti quit moving in the middle of a busy intersection, or when you are passing another vehicle ?

By Dan Booth
Nostalgic Motor Cars

Avanti Repair

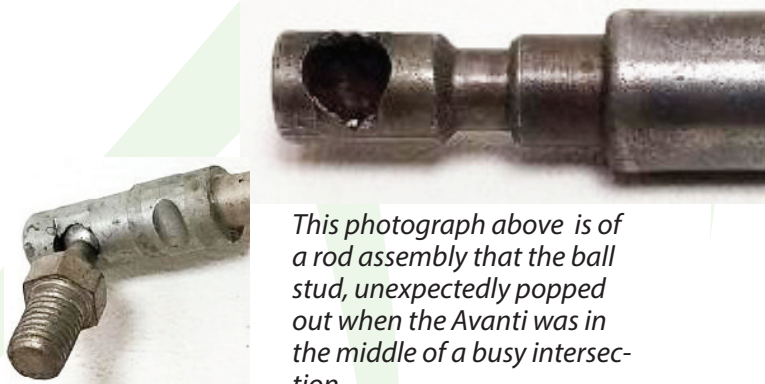
This photograph above is of a rod assembly that the ball stud, unexpectedly popped out when the Avanti was in the middle of a busy intersection.

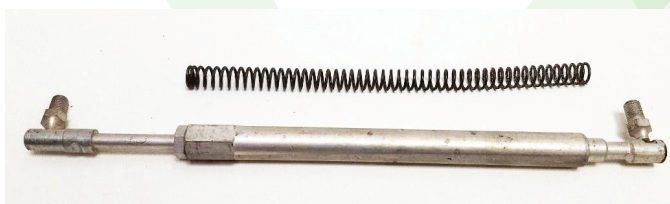
This photograph is of a New Original Stock rod assembly 1539610/1539612 I also cut one open, so you can see the spring that's inside.

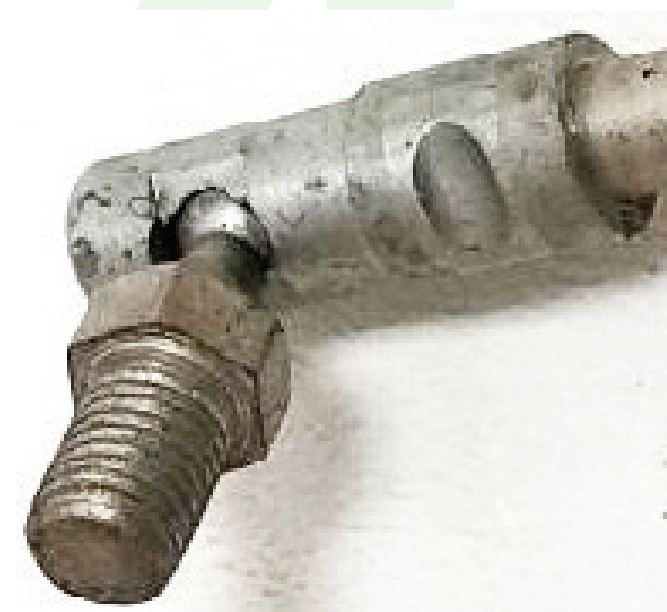
Crimped Sides

Each end of the rod assembly has a small ball stud that has 1/4-28 threads and a nut to bolt it to the carburetor & the bell crank assembly The ball end simply goes into a drilled hole, in each rod and is then crimped over on two sides. Those two crimped sides are the only means of keeping the ball stud in place. As the ball studs and holes wears, so does the crimped steel.

It will simply pop out. I know of no way to repair them. But after being on the Avanti for 41-58 years, I think it may have served it's purpose and for safety sake, replace it while they are still available. This Rod assembly #1539610/612 was installed on all 1963-1964 R-1, R-2, R-3 with the exception of the small end for the R-3 #1560692 was a different style. This rod assembly was also installed on all 1965-1980 Avantis. Again with the exception of the small end 1539610 Like the R-3. on some years (early 1970's) the small end was longer and/or had some bends in it.

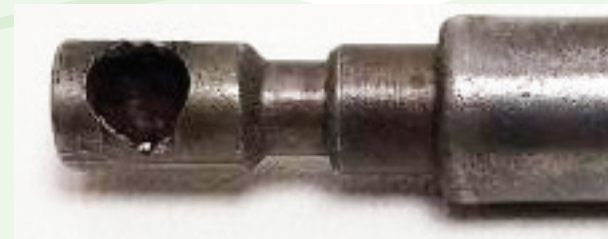
This photograph is of a rod assembly that the ball stud, unexpectedly popped out when the Avanti was in the middle of a busy intersection.

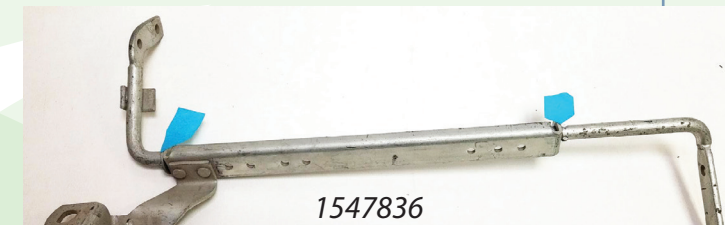
1547836
Blue Arrows show wear points

Most of the time these bell crank throttle controls will have a lot of play in the 2 formed pivot points. (one on the top and one on the bottom) where the main shaft pass through the main bracket. There should be no more than about .005 play side to side. A normal sheet of paper is about .003 -.005 thick If the two pivot points have wear, when you press the accelerator instead of moving the throttle, that shaft will first move sideways in the pivot holes before the responds to the carburetor. Then when you return to idle, it will not respond correctly and makes the car idle higher than normal until you hit the accelerator fast and hard to force it return properly. Some owners or mechanics just install a much heavier return spring and think that fix is it. All that does is kill your angle from too much resistance and the wear factor only increases. The very rare N.O.S bell crank throttle control # 1547836 is \$195.00 while supplies last.

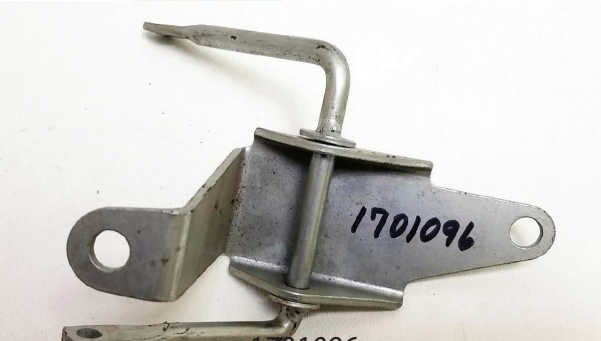
1701096 Bellcrank 1975-1980 the third style bell crank throttle control is 1701096 This was installed on 1975-1980 Avantis. This can have wear again at the pivot pints, where the shaft goes through those pivots. A new one will have about .010 play, side to side. This very rare N.O.S. Bellcrank throttle control # 1701096 is \$175.

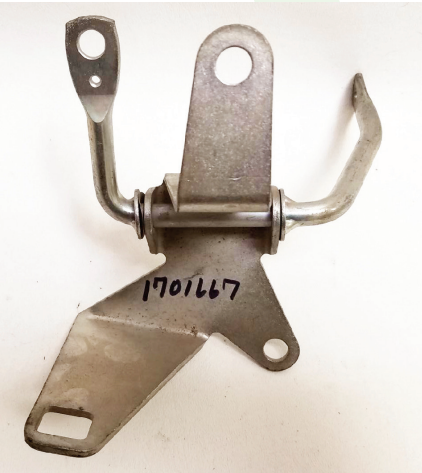
1701667 bell crank 1981-1985 The 4th style bell crank throttle control is 1701667. This was installed from 1981-1985. This can have wear again at the pivot points, where the shaft goes through those pivots. A new one will have about .010-inch play, side to side. This very rare Part# 1701667 N.O.S. bell crank throttle control, at the time of this article is \$175.

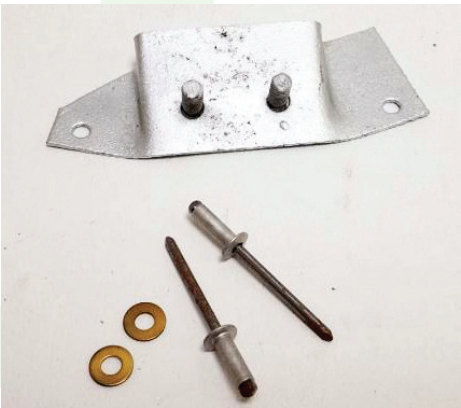
The accelerator pedal Illustration #0312-1 part #1560745 also plays a big part of your throttle returning to the preset idle. The hinge that is built in the pedal assembly is covered in rubber. If this rubber is not the correct thickness and/or the durometer of that rubber is not to the blue print specifications. It will not return correctly a N.O.S Accelerator pedal Illustration #0312-1 part #1560745 is \$65. Just because your original accelerator pedal still looks ok, and works, doesn't mean it's working properly What happens, over time, is the old rubber breaks down and may start cracking from the steel hinge assembly inside that rubber, that is rusted, seized or just worn out.

Avanti Motors was aware of accelerator pedals Part#1560745 breaking down where the aged rubber is covering the rusting hinge. They designed a bracket (Left column at bottom) that raised the accelerator pedal, up off the floor. the original accelerator pedal was just bolted to the floor from 1963-1976 with nuts and bolts. The new bracket 1701340 was riveted to the fiberglass floor. Then the accelerator pedal was nutted on to the 2 welded studs. This bracket raised the pedal slightly and gave the pedal little more angle to help return the throttle to idle

This very clever improvement does have a down side. After 36-45 years, they can be rusted out. This very rare N.O.S. bracket kit Part# 1701340 is \$35. It was installed in all 1977-1985 Avantis, but will fit and improve all 1963-1985 Avantis.
