Is your Avanti REALLY Safe to Drive?

How To Replace the Steering Flange and Insulator (Rag Joint)

How To Change a NOS Avanti Rag Joint from 1963-1985

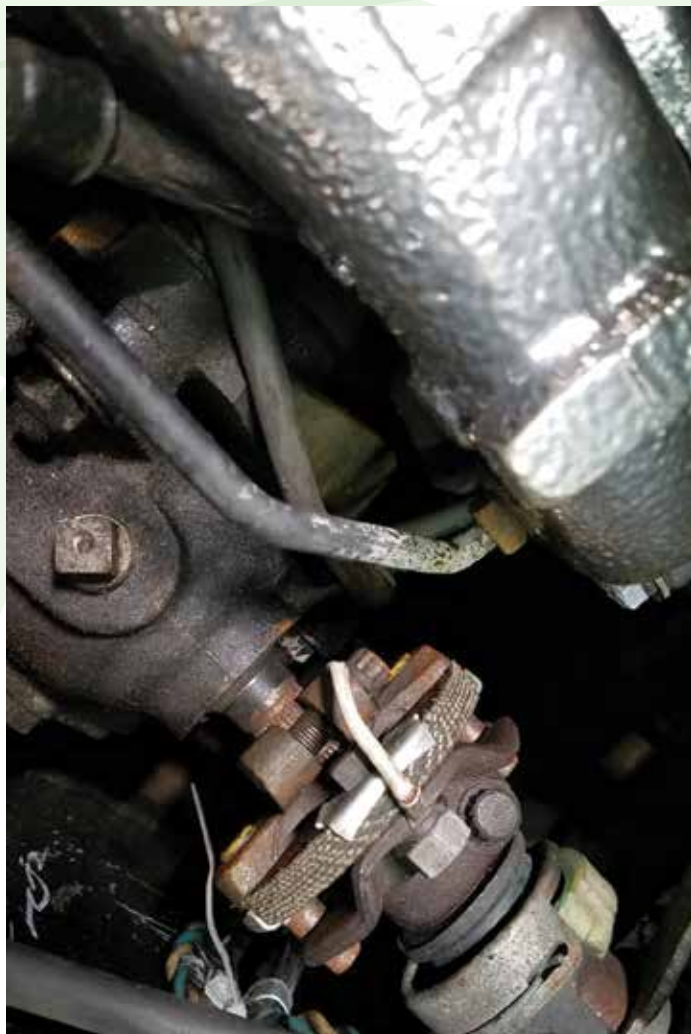
New Original Stock Rag Joint #1701886, Installed with jumper ground wire

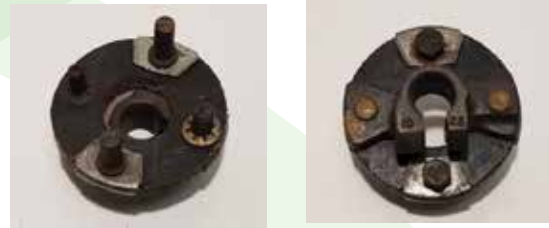
The pictures show a NOS rag joint #1701886 and a rag joint I removed form a 1981 Avanti (39 years old). This 1981 was shipped to me with a little play and vibration in the steering, that nobody else could figure out what was wrong. I decide to change the rag joint, knowing there was no play that I could see in the rag joint. The NOS rag joint solved the problem of play in the steering.

I inspected the old rag joint. I took out one of the attachment bolts from the rag joint and noticed that the hole was becoming elongated and split on the outside of that hole. I further flexed the rubber and noticed it cracked at the edge of the steel retainers. In the photo, look at the fuzzy threads that show where the hard rubber and fabric are cracking, breaking and tearing, and etc.

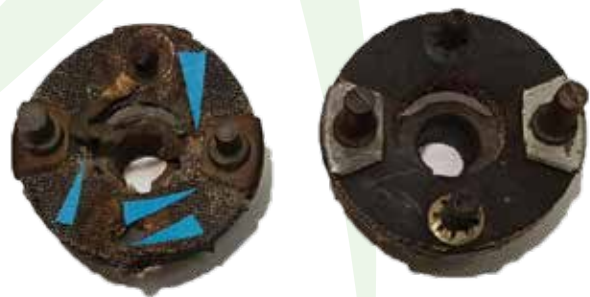
It's hard to see the cracks in the image above. The blue tape in the below image is cut to make arrows, pointing to the cracks.

**#1557139 #
39 year old Rag Joint**

**#1701886
New Original Stock Rag Joint**
