## NOSTALGIC MOTOR CARS UNLOCKS THE HISTORY & MYSTERIES OF THE 1963-1985 AVANTIS

### Why Do Some Avantis have bird house holes?

**By Dan Booth**

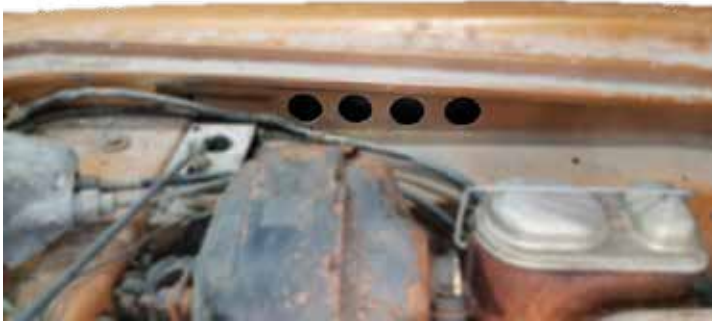
These holes are in the top of the inner aprons, just in front of the hood lock plate assembly illustration number 1622-65, in the parts manual.

under the hood temperature. It didn't seem to work as well as anticipated. If you think about it, as the car is moving down the road, it seems to me that the pressure from under the front fenders would somewhat block the air from exiting these holes. It might help the hot air to escape the engine compartment when the car was not moving.

The holes are referred to as "Bird House Holes," Avanti Motors started installing them sometime in the very early 1970s production, and continued until about the late 1970s or early '80s when they were eliminated. When they first started installing the bird house holes, they drilled 4 to 5 holes of different sizes that started with a small hole and progressively got larger. I believe the small hole started at the front and ended with the larger hole just in front of the hood lock plate assembly illustration number #1622-65 in the parts manual. Somewhere, about 1973, they switched to four 1½-inch holes with ¾-inch spacing between the holes. I believe the purpose was to increase the air flow from the engine compartment which would assist in lowering the

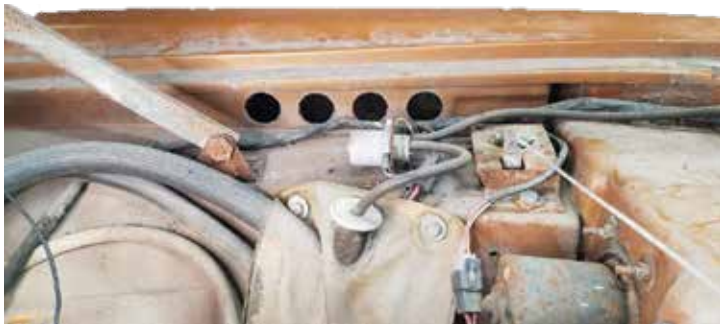
I think this idea would have worked better if it was ducted down and open to the back. Unfortunately there is no room for a duct to go down the total height of the inner apron and/or the cowl panel and then face to the rear
