# Avanti Repair

### N.O.S. Avanti Rear Axle Radius Rod Front Mount Repair kit Part number 1702281

**By Dan Booth**  
Nostalgic Motor Cars

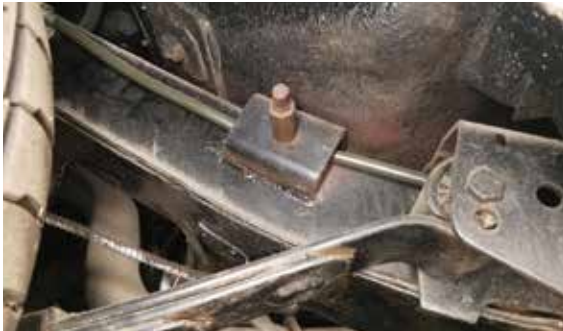
This picture shows the stud that could break

I have been asked to write an article about the Avanti part that most owners, or mechanics, aren't aware of its existence. The part number is 1702281 It's a repair kit made by Avanti Motors for the replacement of a broken stud, on a bracket that's welded to the frame. This bracket is the front mounting point for the rear axle radius rod illustration number 1001-16 where the original stud breaks. When broke, the radius rod will hammer against the frame. It is very easy to change and a life saver when the stud breaks.
