By Dan Booth
Nostalgic Motor Cars

Does the reach rod of your power brake booster (for about 1971 through 1985) that pushes the master cylinder piston have the correct parts and/or adjustments? It's very easy to check!

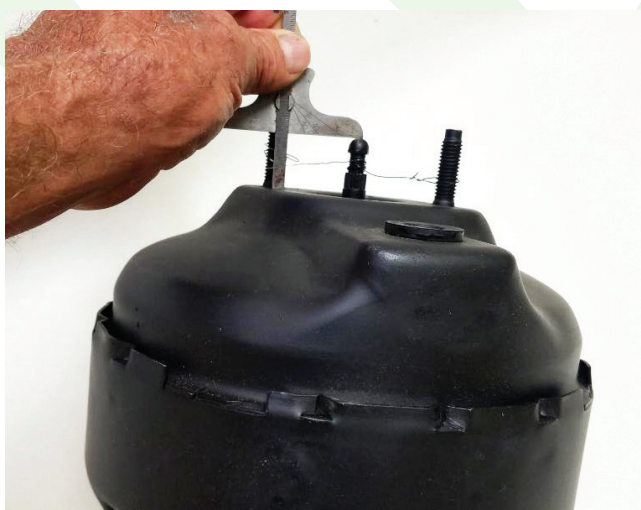
.985 off the flat face of the booster reach rod, to the tip of the adjustable end.

The correct master cylinder would have a female acorn counter bore (see photos next page) in the back end of the piston. The correct depth of the rod was to be adjusted at .985-inch off the face of the flat part of the booster. The problem was that Bendix installed the

wrong adjustable end on the rod. It had a flat end, instead of an acorn end. This would make your reach rod wrong for on the adjustment. The rod would be too long and the brakes would always be on to some degree and shorten the life of your brake pads, rotors and shoes.

If you have the flat end, going into a female acorn counter bore, it will be riding up on the curved sides of the counter bore and make the rod too long. You don't have to purchase an acorn end—I have them in stock—if you have a flat end. It can be turned down on a lathe. To this

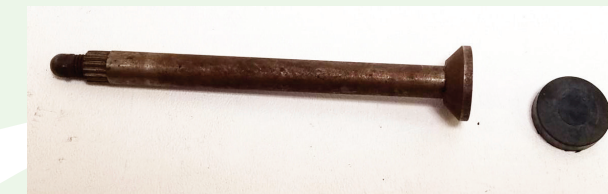
Flat End

Acorn End

Acorn (correct) adjustable end

Flat (wrong) adjustable end
