NOSTALGIC MOTOR CARS UNLOCKS THE HISTORY & MYSTERIES OF THE 1963-1985 AVANTIS

The Unknown Clever Thinking of the Altman's Avanti Motors

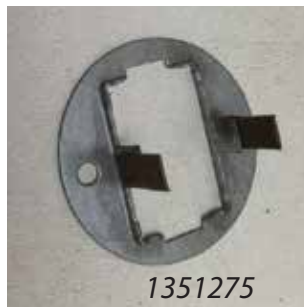
Studebaker only sold the switches as an assembly according to the parts manual. I found no separate part numbers, in the parts manual, for just the switches. I sell the N.O.S. separately \$90 each. The switches are held in place in the chrome escutcheon with some special clips #1351343 \$4 each, which I have in stock. These special clips server two purposes. They keep the switches in escutcheons and they are supposed to keep the switch assembly snapped into the mounting plates that are attached to the door panels.

Clip 1351345 \$4.00 ea.

These clips are made of spring steel and if they are retaining their original shape, and tension, they still only have a small area of about .050 where the clip can rest on the stamped steel plate unless you force them further out. It's only natural for the special clips to lose their ability to stay open and hold the switch assembly in place. If the hole in the cardboard door panel was cut (or shrunk) a little too big, this also contributes to the problem.

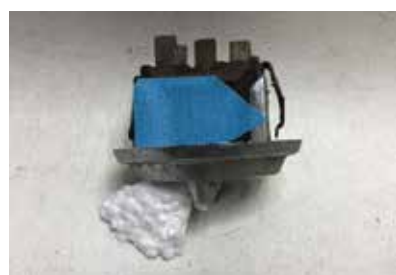
Switch, showing clip

This is where the very clever thinking of Avanti Motors resolved a Studebaker problem. A very simple, inexpensive solution. They simply slid rods one on the top and one on the bottom through the special clips #1351345. This forces and keeps the clip out, which in turn keeps the switch assembly in place.

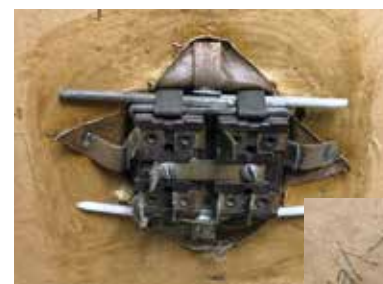
Driver Side

Switch held in place with nails

The second method Avanti used was to cut the heads off some nails (sometimes they don't cut the heads off) and insert them through the special clips. The nails are the most common over the rods. If your Avanti repair shop experience did not come from working on the Avantis when they were new, you may assume that somebody did a little creative engineering with what materials they had on hand, using nails. Note; the rods or nails should be taped to the cardboard door panel. What we don't know if these fixes were done on the assembly line, or done by Avanti Motors service department. They work extremely well and the nails seem to be the most shocking of the two. I've had a

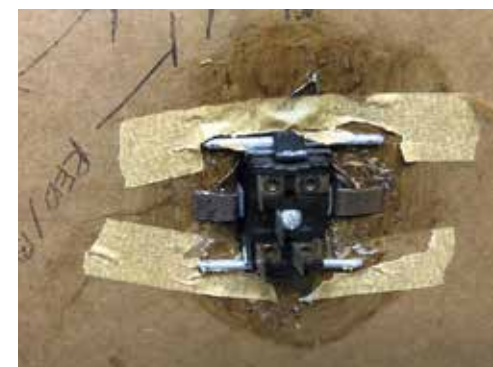
When I remove a door panel with electric power window switches, I draw a wiring diagram on the back side of the door panel. The diagram shows the color of the wires and where they are plugged into the switches.

I just pulled the door panels from one of my personal, all original 1969 Avantis. I purchased it from the original owner, who ordered it on 8-14-69, from Avanti Motors. The Avanti was always serviced by Avanti Motors and never driven in the winter and only has 31,972 original miles. I don't think the door panels have ever been removed from this Avanti, since it was built and delivered on 9-17-69. All the moisture tape was original and had never been repaired or replaced. There was also no wiring diagram on the back side of the door panel, which is normally drawn by the first person to remove the door panel.
