The unknown facts and history of the Avanti Dash Lighting from 1963-1985

By Dan Booth
Nostalgic Motor Cars

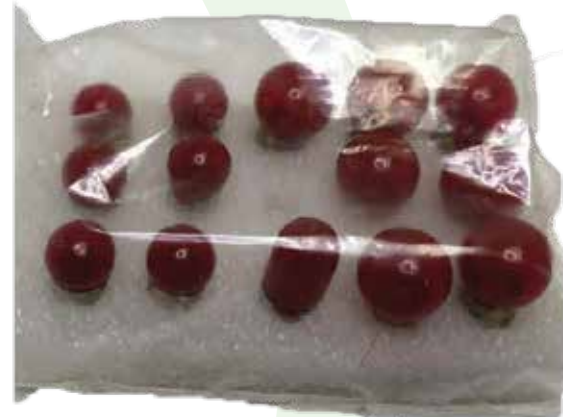
The style used in 1963-1973 was what I call gang lighting. The fuel and oil pressure gauges were in a case, pictured above, Illustration #1701, Part number 1557114 (which are available at \$15.00). This case had one hole for just one light bulb. The gauges have four small slits in the side to allow light in the gauge.

As you can see by the photo above, the light bulb is in the center of the two gauges. The case is painted white on the inside, to aid in the illumination. The temperature gauge and ammeter gauge were the same but with a different case, Illustration #1709 Part number 1557115 (also available at \$15.00). The clock and vacuum gauges each had their own bulb.

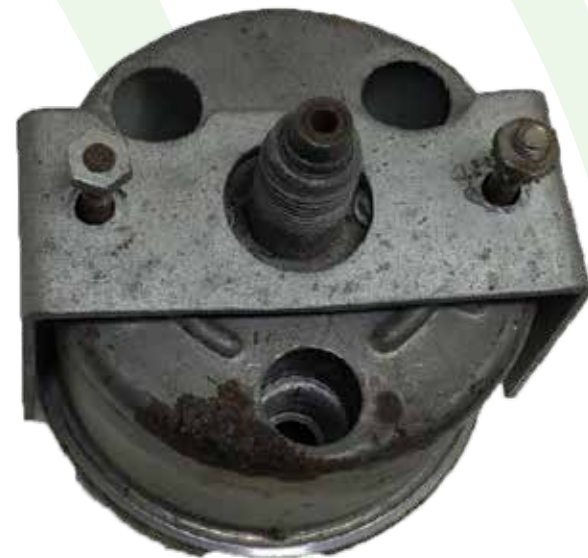
Both the 140 and 160 mile-per-hour speedometers had three holes for bulbs. The two top holes were for illumination of the gauge. The bottom hole is for the bright light indicator and this bulb was not red, but clear and not included in the bulb kits.

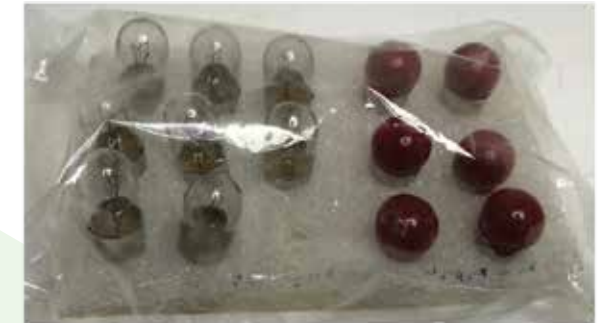
Red /Clear bulb kit 1974-1983½

The new black bezel gauges were first installed in the 1974 Avanti and continued through 1983½ and was also the first time that Avanti changed from a mechanical oil pressure gauge—which had a copper tube that carried engine oil to the dash gauge—to electric.

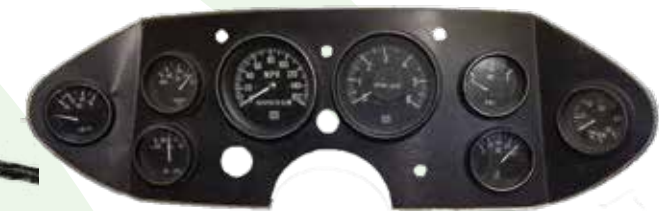
The tachometer, above, has two holes, one at about eleven o'clock and the second at about the five o'clock position. Most light bulb changers don't know about the light bulb at eleven o'clock, and they often totally miss it when they change bulbs.

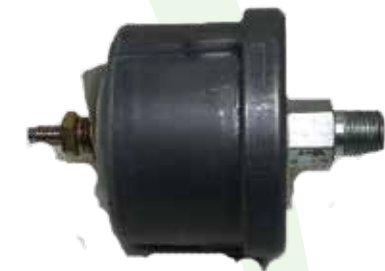
1700894 \$80.00
1700890 \$80.00
1702038 \$105.00

This new black bezel oil pressure gauge 1974-1983½, was now electric. It had an oil pressure sender located under the distributor. The tachometer was also changed to a totally electronic unit and did not have a sending unit, Part number 1701003R \$250.00, unfortunately these new gauges left something to be desired, when it came to night time lighting.

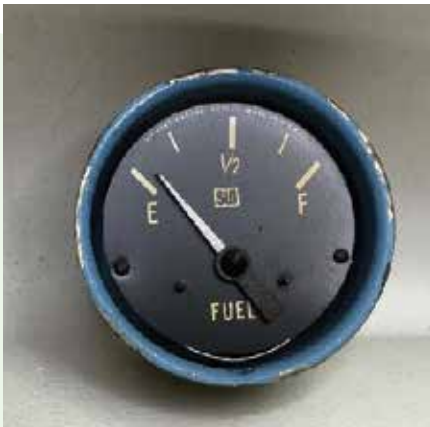
Black bezel gauge with bezel removed

The gauge dial (above photo) seems to be too large in diameter for the size of the case, which doesn't allow enough light to get around from the bulb in the back to the dial face. When the bulbs are new, you can read all your gauges, but as the bulbs age, they become darker.

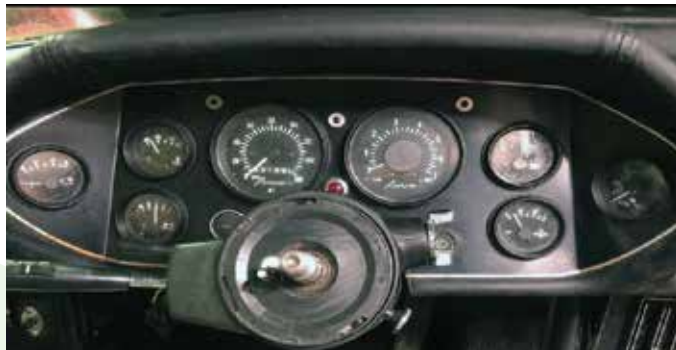
instrument resistor Illustration #0615-6 Part number 1557964 \$90.00 were no longer used, which made the dash lights very bright with no provision to dim the lighting

The red dash gauge lighting was back, for 1984, but it was different than what was used from 1963-1973.

The light bulbs now had a little red booty installed. The booty gave a much better, uniform red lighting on all the gauges. Unfortunately, the little red booty would change color to more of a rust color with use. As these red booties aged they became very hard and brittle from the bulb heat and changed to a rust color, and the bulbs turn black faster. This was one of Steve Blake's many ideas, that was not well tested before putting into production.

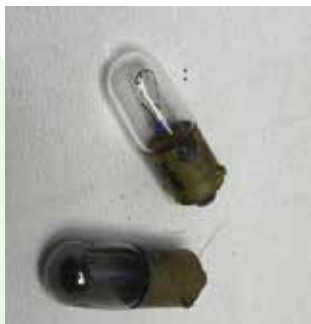
New, clear bulb

Used bulb, that turned black

Unfortunately, as the bulbs are used, they will turn black on the inside, which imprisons the light, that's why Avanti owners can't read their gauges at night.

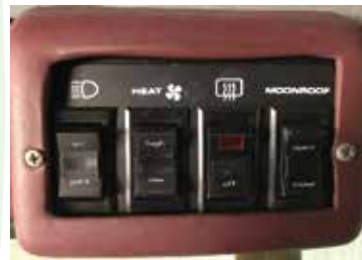
The beautiful red light, some say sexy, overhead switch lighting and it's soft crash pad Illustration # 2180-6 was now gone for 1984 and '85. The crash pad and it's six switches were replaced by two different switch panels. One panel had three switches, headlights, rear deicer and heater blower motor, Illustration #2180-6 Part number 1750863-3 \$75.00. The other switch panel had four switches with the same three switches as the first, but the moon roof switch added Illustration #2180-6 Part number 1750863-4 \$75.00.

The soft crash pad, Illustration #2180-6 was replaced with a leather, or vinyl covered, plastic bezel. These two new switch panels had very small clear light bulbs, that were not replaceable. You had to purchase a new three or four switch panel if you had non working bulbs. Fortunately, I still have some of these in stock.
