## How to Prevent Your 1963-1985

## Door Panels from Warping

# Avanti Repair

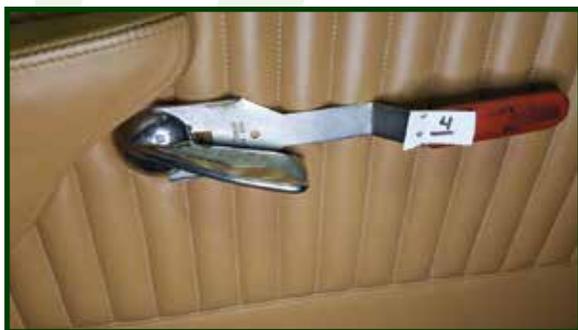
If you have never removed an inside door handle, or window crank handle, this is what you will be doing pushing out that clip see photo below. If you don't have one of these tools I have them in stock for about \$5.00.

Remove the inside door handle with the door handle clip remover (photo#4).

The removal tool will push out the horse shoe retainer clip from a slot. The open end of the horse shoe clip should be facing the long end of the handle, if it was installed correctly. After the clip is removed, the handle will pull straight off. Remove the window crank handle (if you have manual windows) with the same tool. If you have a 1970-1984 Avanti with the door pull strap photos #5. Remove the 2 chrome caps and then remove the 2 screws. If you have a 1985 Avanti with the arm rest and pull handle as a unit then remove 3 screws. Remove the screws that secure the door panel to the door. Lift the door panel up and off.

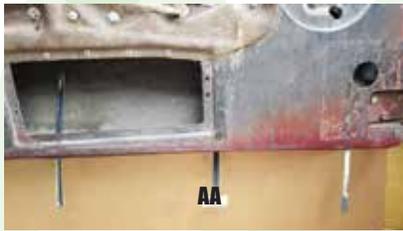
There are 4 water drain slots in the bottom of all 1963-1985 Avantis. If the door is dry on the inside, I vacuum and blow out the inside of the door. I then slide a hack saw blade up through the 4 - 2½" long slots on each door bottom. Then blow up with compressed air through those 4 slots.

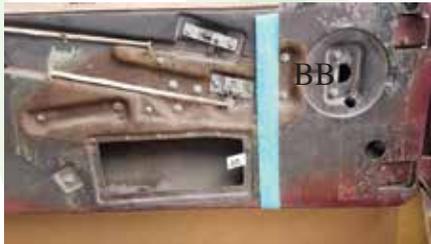
Avanti Motors Used to give me a roll of what appeared to be black masking tape, about 8" wide for warranty repair. That covered the access hole in one piece

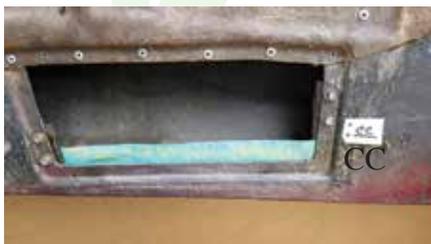
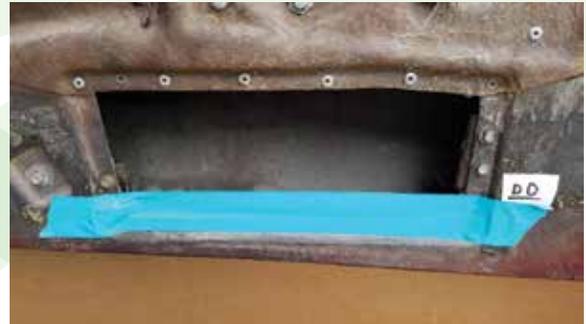
I use 2' wide masking tape. The first layer of vapor barrier I stick to the door (photo BB), and spray glue over top of the original glue. Let it flash a little then place it in the bottom inside of the access hole, Photo CC

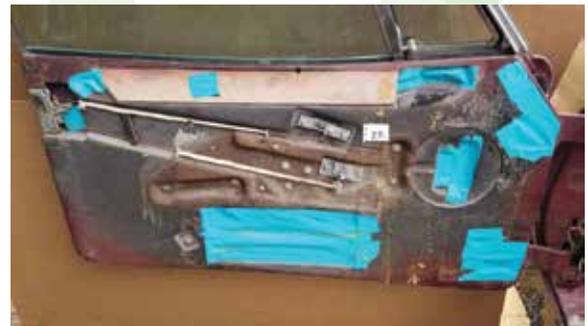
I apply spray glue to all the 2' wide tape as I am installing them. Start at the top and work your way down overlapping about 1/2". It's super important to completely cover the bottom inside the first piece you installed.

Tape up the remaining holes, and you're ready to reinstall the door panel.
