Nostalgic Motor Cars Unlocks the History and Mysteries of the 1963-1985 Avantis

How To Change The Evaporator Core 1963-1985 Avantis

By Dan Booth,
Nostalgic Motor Cars

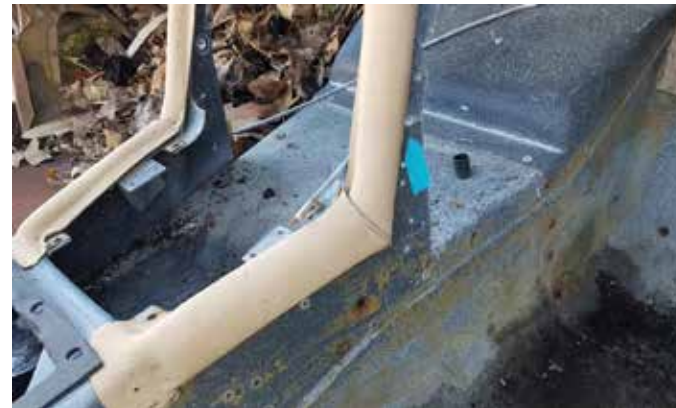
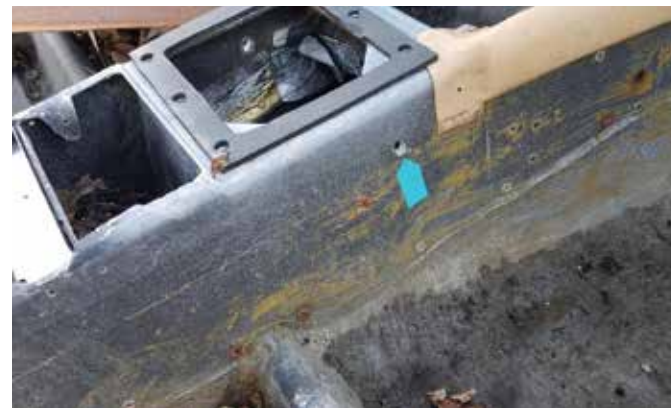
1. Disconnect you battery
2. Remove the vertical A/C air vent panel, 2 screws, unplug the switches
3. Remove the ashtray assembly - 2 screws, and unplug the cigar/cigarette lighter.
4. Remove the shifter console cover - 4 screws
5. Open up the console door 1963-1976 about or remove the E-brake cover about 1979 1985 - 3 screws
6. Remove the 6 screws that hold the automatic shifter to the console
7. Remove the nut that holds the vertical stainless molding to the side of the console, remove that molding

8. Lift the shifter assembly up (you don't have to remove it) Remove the nut from the console that holds the stainless molding

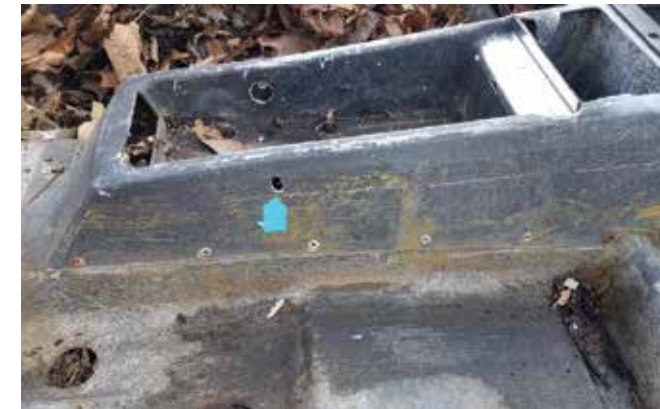
9. Remove the passenger seat

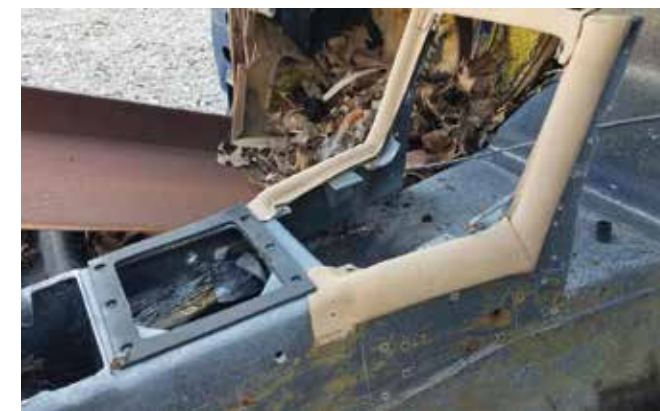
10. Remove the last nut from the side of the console location, inside the console glove compartment or where the E-brake cover is.
11. Remove the screws (about 8-10) that hold the right front console side panel (with round vent) to the console and the tunnel. Note, most screws are under the edge of the carpet. Lift up the carpet to expose the screws and remove this panel

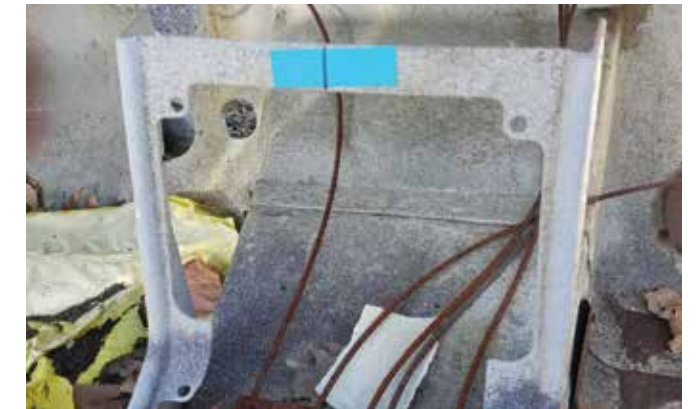
12. Carefully remove the upholstery from top right side and bottom side of the console and there could be a small narrow

strip (about 1/2 wide) on the very top of the console directly below the dash. Remove the carpet from the console side Cut the very top of the console (it's about 1/2' wide) directly below the dash in the middle

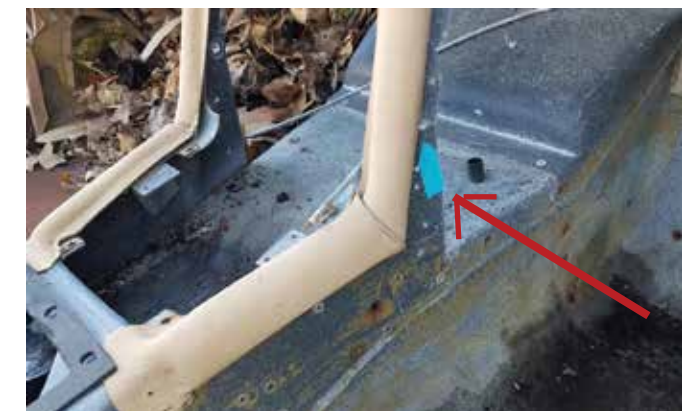
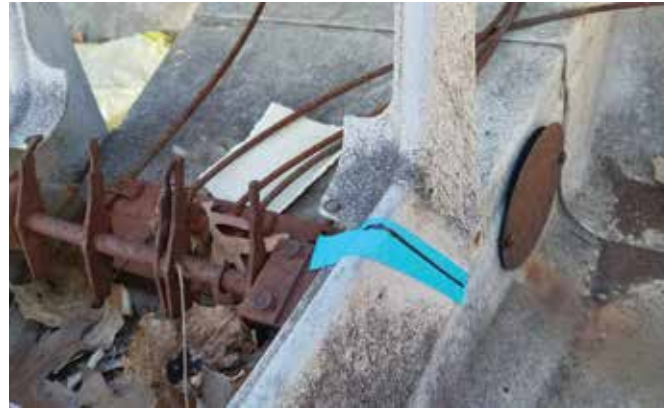
13. Remove any rivets that may hold the side of the console to the tunnel (only on the very front)

14. Draw a line on the console on a diagonal starting about 1" in front of the riveted bracket that holds the heater/fresh air cable assembly bracket to the console side and continue to the bottom console and angling forward.

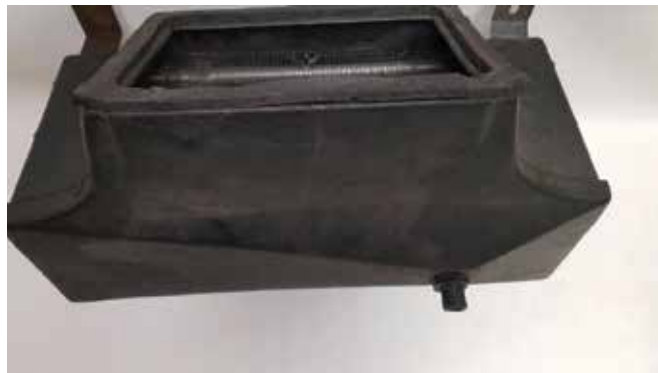
15. Start cutting on that diagonal line. Don't forget where the console side is bonded to the side of the tunnel, you can only plunge 1/8" deep, otherwise you will cut through the tunnel fiberglass.

16. Take some large flat bladed screw drivers and carefully tap down between the inside of the console side and the console tunnel. you will be peeling off the console (its a lot like peeling a thick skinned orange) From the tunnel side (don't forget you will be re-bonding this back together)

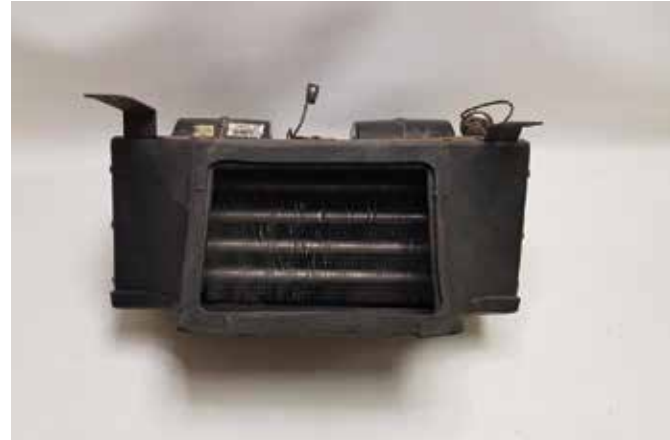
17. Remove one bolt on each side of the bottom of the dash that holds the A/C evaporator assembly to the dash.
18. Now the assembly is ready to slide it out. As you are lifting and sliding out the assembly. There is a plastic nipple with a water drain hose, on the very bottom that you don't want to break. I lift up and out, enough to cut the old drain hose off, and I will replace it before I reinstall the assembly.

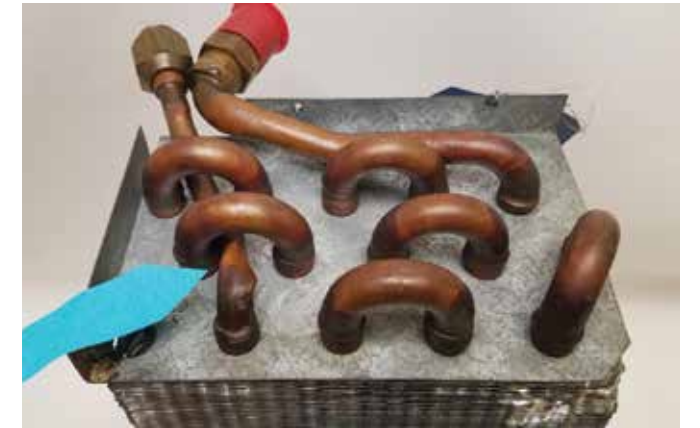
When I stated that it takes one person to hold the wrench tight, and the other to tighten down the fitting, I am not kidding. Here is an example of a N.O.S. A/C evaporator core I sold in August of 1993, to an A/C shop in Texas. I told this gentleman about flattening out those seams, but he must have thought that it was not necessary. After he installed the evaporator core, he called me and stated the evaporator core was leaking. I told him that they were all pressure tested, before shipping. He insisted on sending it back to me. When I got the core back, I could see the small copper line had been twisted almost 180 degrees and that was where it was probably leaking

I pressurized the core, put it under water and the core was not leaking, much to my surprise, even after he had twisted it almost 180 degrees. Where it was leaking was at the fitting. He either didn't use a/c oil when tightening. Didn't do it 3 times or he just didn't have it tight. I gave him a refund and asked him to find one somewhere else. He couldn't find one anywhere else and sold the car with out the A/C working.
