Do you smell gas inside your Avanti?

By Dan Booth
Nostalgic Motor Cars

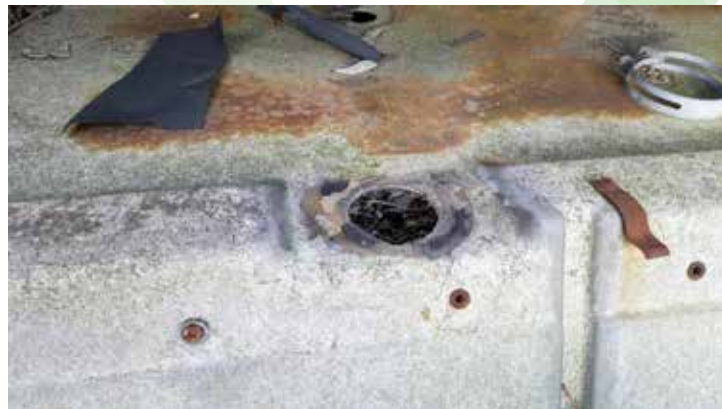
Studebaker drilled a large 1 3/4" hole in the floor pan in front to the gas tank just behind the rear seat back panel ill# 2160-119, I believe this large hole was to allow gas and/or fumes to escape to the outside of the car If the tank ever had a leak. This 1 3/4" hole was eliminated some time in the 1963 product run. This large hole can allow moisture to collect inside of that normally dry compartment.

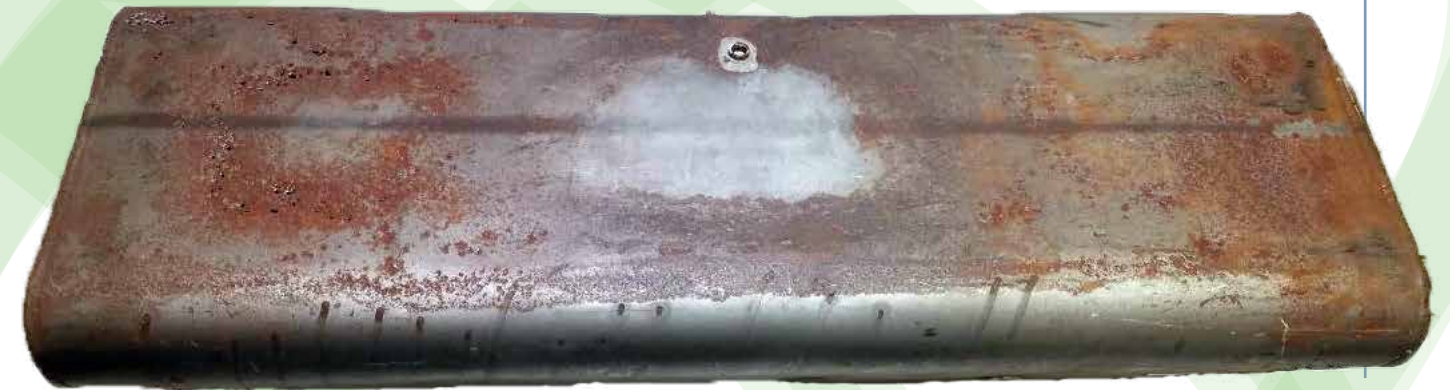
I have seen Avanti gas tanks that were severely rusted on the bottom, from setting in water between the bottom of the tank and fiberglass floor pan, from years of a leaky rear window.

Since the Avanti gas tanks are now 36-58 years old, rust , old gas residue and what ever else that has collected inside the tank is very difficult to remove, because of those 2 baffles.

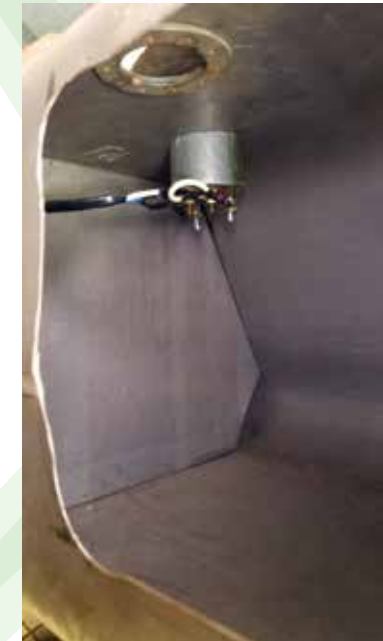
If you study this picture, at the right, of a 1963-1985 Avanti gas tank, that I cut a large hole in the front. It clearly shows why it's almost impossible to clean the inside of an Avanti gas tank good enough to eliminate the rust, old dried up gas residue, and whatever that is being trapped in the fuel filter.

The unit sticking down from the top of the tank (you will not have this in your tank) it's a N.O.S. fuel gauge I installed for setting up the floats for correct calibration.

This picture is showing what the baffles look like inside of a 1963-1985 Avanti gas tank.

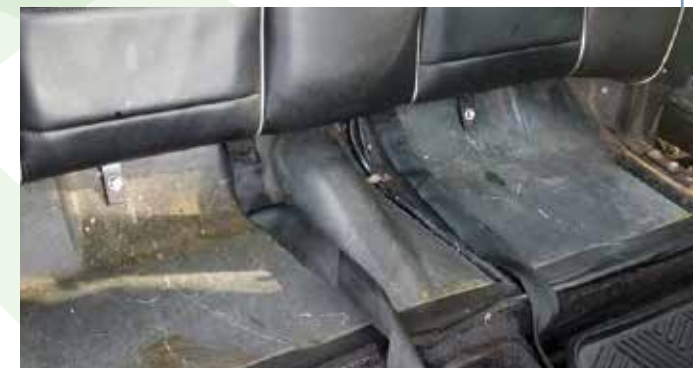
#WLN Well Nuts (2 required) \$3.50 ea.

3. Remove the 2 bolts that hold the back seat back to the floor. If somebody has installed nuts & bolts this can be a problem, because it may take 2 people. One to turn the nut as the other holds the bolt. All 1963-1985 Avanti originally had a special rubber incased nut that pushed into the holes in the floor and expanded as you were tightening the bolt. If you don't have them I have them in stock @ \$3.50 ea.

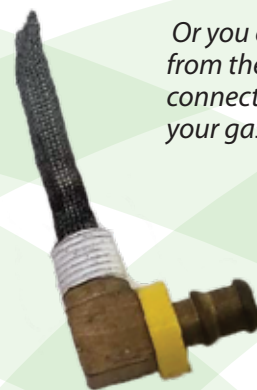
Or you can remove the 3/8" gas supply hose (coming from the bottom of the gas tank) from the fuel pump and connect a piece of 3/8" hose to that hose and place it in your gas cans.

5. Drain the gas tank, I pinch off the gas supply hose on the bottom of the tank, then I cut the hose and splice in a 6'-8' long piece of 3/8" gas hose. run it over to some gas cans. Release the pinched hose, after the gas was drained out. I remove the hose and then remove the elbow on the bottom of the tank ill#0308-8 part # 1544868 or 1701339. In 1973 Avanti Motors improved this elbow. They added a screen sock to the top. This new elbow was assigned part #1701339. The idea was it would stop any debris or small piece of solder from landing in the center of the elbow and stopping the flow of gas, and it worked extremely well.

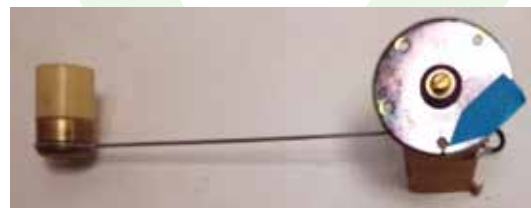
Now install a 1/4" pipe plug in the hole, preferably one with a hex socket fitting, as they are flat. Instead of sticking down. They make it much easier to remove the tank from the compartment. Remove the wires that are connected to the sender, 18 gage, white is ground, 18 gage red with a black tracer goes to the gas sender insulated post. If you are removing the gas tank the sender can be removed after the tank is removed, but follow these instructions.

If you are only removing and replacing the gas sender. Take a felt tip pen and mark the front of the sender, while it's still in the tank, facing directly forward, towards the windshield.

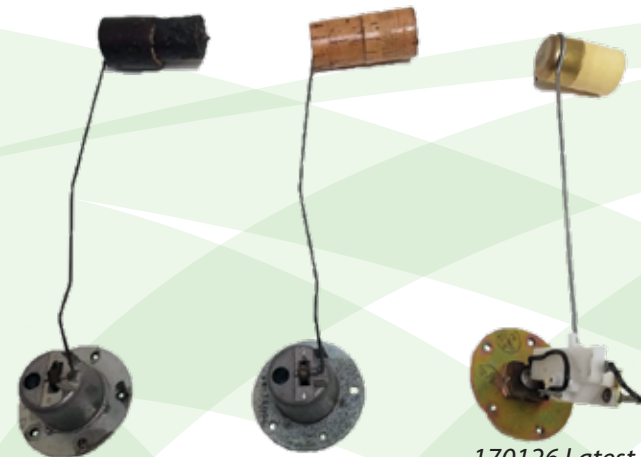
These are the only style senders ever installed by Studebaker and Avanti Motors. Illustration #0307-20

If the sender you have does not look like the ones in the above picture. It is a reproduction like others sell.

The original Avanti gas sender from 1963-about 1985 used a cork bobber, they took 2- 1 1/4" diameter x 1 3/8" long corks, glued them together and then coated them with some type of sealer then attached them to the float rod. As time went on, the corks would start getting heavier as they started to take on liquid. That's normally why the gas gauge starts to become inaccurate, plus the electronics just wear out

The last style sender Avanti Motors installed is a lot different. It has totally different electronics and the bobber is no longer cork. It appears to be some type of Styrofoam.

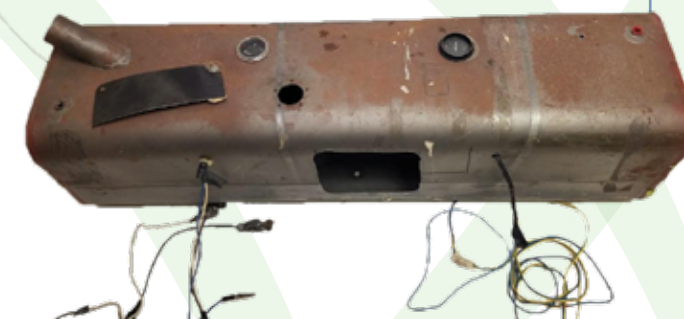
This is a new Avanti gas tank that I cut a large hole in about 35 years ago. I installed a N.O.S. 1963-1973 chrome bezel fuel gauge part #1557110R and a N.O.S. 1974-1985 black bezel gauge part #1700893 in the top. I use this tank to adjust the float rod on the N.O.S. gas senders. I adjust the float rod so when the gauge needles is pointing to the empty mark, you will have about 3 gallons of gas left in your tank. Doing it this way it does limit where the full reading will be. In other words when you fill up your tank it will probably only read 7/8" full I personally like to know I have about 3 gallons of gas left in the tank. when it's on empty.

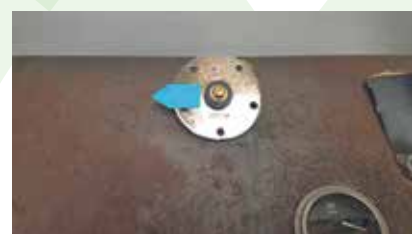
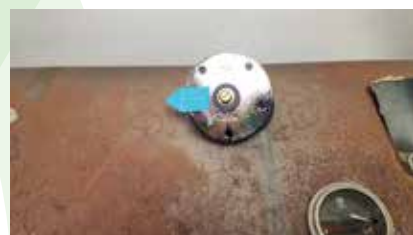
Remove the 4 remaining #10 x 3/4" screws part#3228x1 and the remaining 4 special copper washer part # 187763

Lift up on the back of the sender as you rotate it up and out of the hole. Give yourself a small file mark on the old sender where you marked it with a felt tip pen. Transfer this file mark to the new sender with a file mark.

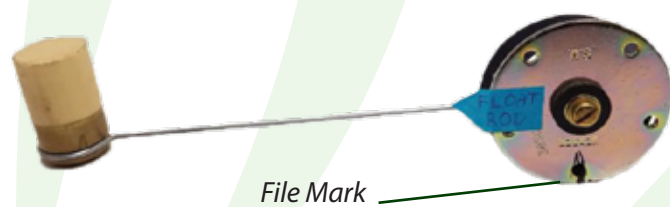
From inside the car, facing the fuel tank If you are holding the fuel sender in your right hand the bobber will be directly to your left 90 degrees away from the file mark This file mark will let you know for sure when the sender is in the tank all 5 holes will be lined up correctly for the 5 screws and washers. Blue arrow points to the bobber.

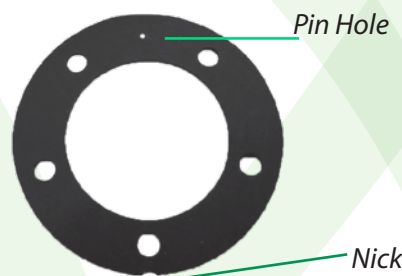
The original gas tank sender gasket illust#0307-21 part #1556074 was cork, I have them in stock \$1.00 ea. This was supersede by part # 1701454 in 1978 and was made out of neoprene for better sealing. It was installed dry. No added sealant was needed.

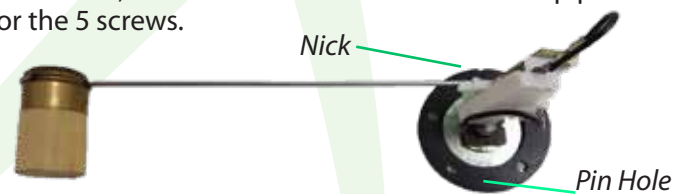
Avanti Motors also did something else that made life a little easier, if you study the new neoprene gasket # 1701454 (which I have in stock and are \$2.00) you will notice a very small hole in between 2 holes. This small location pin hole gets lined up opposite that file mark I had you install, that faces straight ahead, towards the windshield. I give myself a nick in the edge of the neoprene gasket as shown in picture, so when the sender is in the tank, the file mark and the nick is lined up perfect for the 5 screws.

If you don't understand or maybe slightly confused. Turn your new sender up side down and place the new gasket on the sender, keep turning the gasket to align the holes. You will discover that when the nick and file mark are aligned all 5 holes are perfect. You will also notice that one position they are almost lined up and the the 3 positions they are way off.

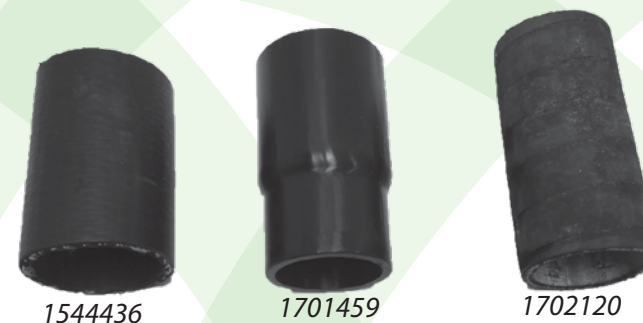
The filler neck hose should always be changed on preventative maintenance, for safety reasons. These filler neck hoses do deteriorate, crack and some turn almost into gelatin. Since all the gas you put in the tank has to pass through this hose and if it ever starts to leak you have big safety problem. The leaking gas will flow into the normally dry fiberglass compartment, then into the trunk. Then under the rear seat. Then onto the carpet. Now after putting gas in the tank you open the door and have a strong smell gas. Do you start the car? HELL NO, you disconnect the battery, now you purchase an N.O.S. filler neck hose and do a complete clean up and wish you would have purchased a N.O.S. filler neck hose from me before this happened!

Clean up the pipe on the tank and the filler neck pipe. Spray some WD-40, inside the hose and on both pieces of pipe. Slide the hose on the tank. I always add 2 extra hose clamps two for the top and two for the bottom, just because the cost is minimal and it doesn't hurt a thing. Slide the clamps on the hose. Slide the hose on the tank. Install the filler neck back through the C pillar and let it rest against the hose. Go back inside and move the hose until it lines up with the neck. Go back to the outside and carefully push down and slightly twist the neck until it slides into the hose. Take a drift or scratch awl and line up the screw holes to 12:00 (file mark). Install the screws, and tighten up the clamps.

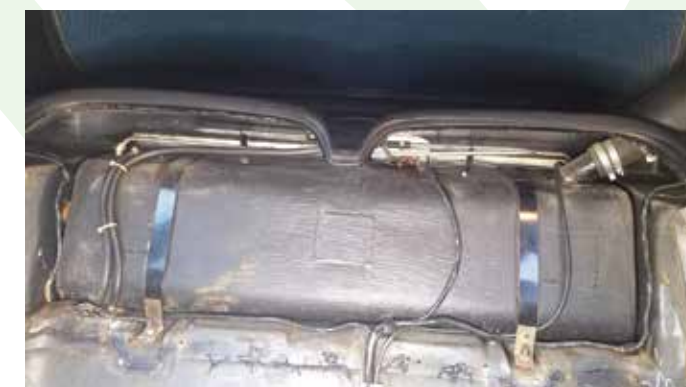
Remove the rubber hoses from the tank, on the later Avantis there is a tubing assembly on top of the tank. Remove the 2 line fittings and the 2 nuts that hold the support bracket. Remove this tubing assembly. remove the 2 nuts from the hold down strap bolts. Now the tank will slide out of the compartment.

When you remove the tank, you will see 2 foam pads, illust# 2130-22-1 one at each end of the fuel tank. They are called "anti rattle pads" they do help quiet down the tank.

Reverse the process to install. Before I install the back seat panel, illust# 2160-119 page #218 in the parts manual. I will fill the tank and go to a parking lot so I can do figure eight circles, to make sure I don't have any leaks.

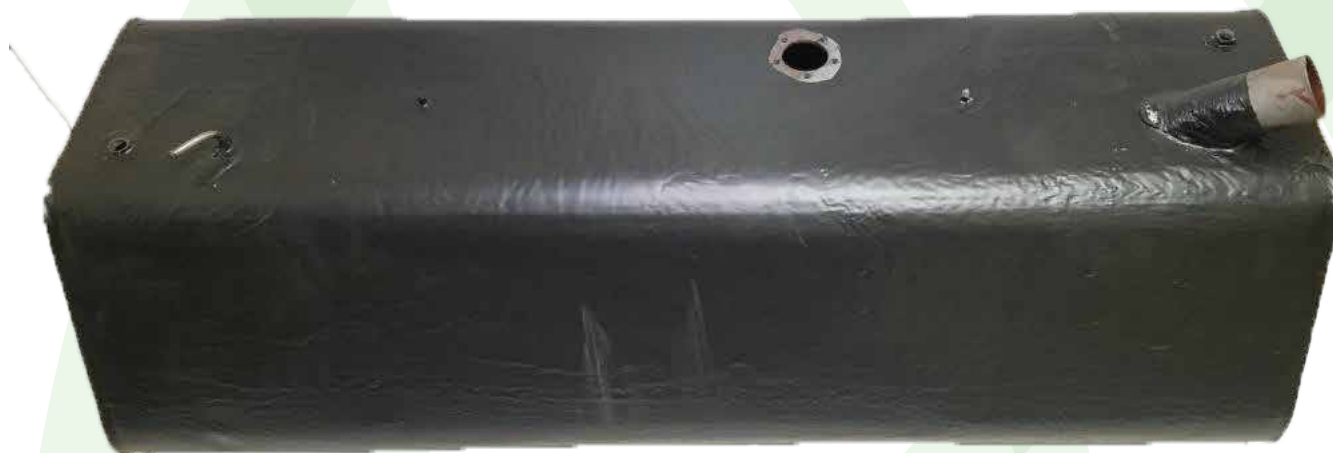
For over 58 years the 20 gage steel that Studebaker engineering, chose to manufacture the tanks from has proved it's safety and reliability. The only problems were rust on the inside from neglect and possibly rust on the outside from a leaky rear window seal. The 1977-1985 leaky gas tanks were caused by too much spot weld heat and/or the heat was left on too long on the bottom, mostly right side baffle. As the gas sloshed from side to side, around the baffles, the spot welds would crack and allow the leak I described. Avanti Motors did not manufacture their gas tanks. They

were manufactured by an outside manufacturer. If the only 2 problems (spot weld leaks and rust) that the 1963-1985 Avanti gas tanks have ever had are corrected, by coating the inside and the outside with liquid PVC plastic on sandblasted steel and you know the tank will fit because it is the one you removed or it's a correct one for your year Avanti that we supplied. Why would you chose a different material like aluminum or stainless steel that wasn't made from the original blue print specifications. They also don't have the safety track record of 36-58 years that the original steel gas tank has.

The cost to recondition your tank is about \$525.00 plus shipping. Call for pricing on other makes and models of fuel tank. they can do all makes and sizes.
