Mysteries of the 1963-1985 Avantis

By Dan Booth,
Nostalgic Motor Cars

The unknown facts, finally revealed in print, about the Avanti Motors Installed sunroofs & moonroofs from 1971-1985

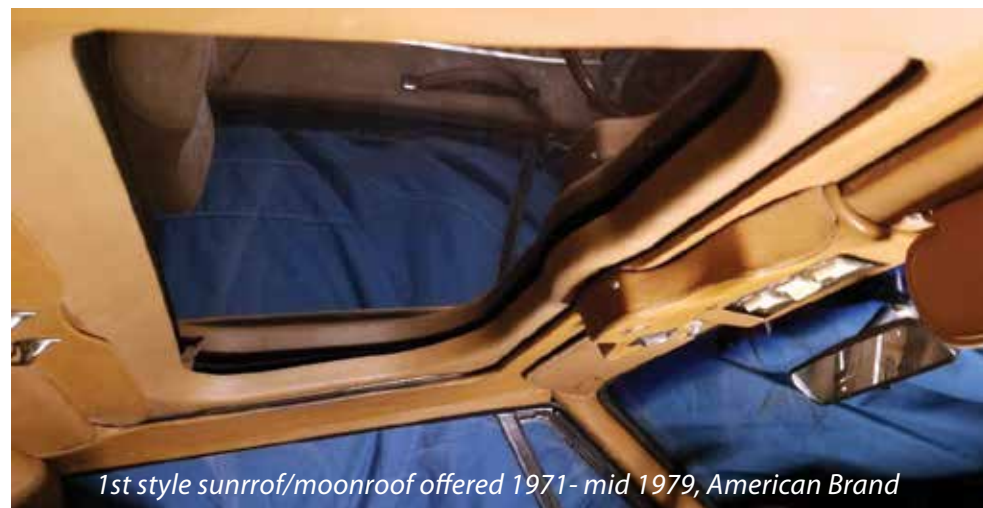
1st style sunroof/moonroof offered 1971- mid 1979, American Brand

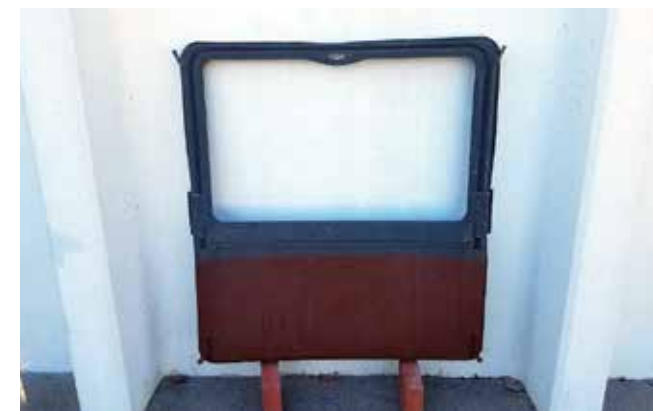
These steel roof housings were bonded to underside and then riveted through the roof skin. Avanti Motors drilled and counter bored through the top of the roof skin and steel housing. Then fastened with pop rivets. Then dressed the roof skin with body filler. Over time this body filler could shrink and you would have small depression under the paint.

The worst problems that I repaired was the body filler over the rivet heads would crack and allow water in, then the body filler would pop out. This was a very easy fix. I simply drilled out the old rivet, installed a new rivet, sand blasted the hole and rivet head, dressed it with body filler, primed and painted.

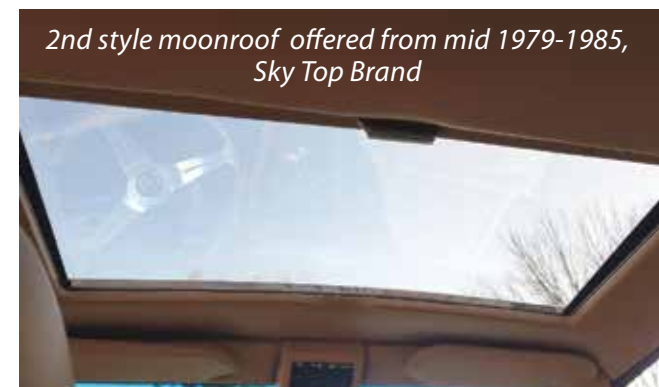
2nd style moonroof offered from mid 1979-1985, Sky Top Brand

The 2nd style was only offered as a moonroof (glass panel) and by a different manufacturer, Sky Top. This new style was first installed some time in the 1979 production run. It was a different size and totally different from the American Sunroof. The American

brand used cables to move the steel or glass panel, the Sky Top style moonroof did not use rivets and only relied on the bond to hold that steel housing to the roof skin. The Sky Top brand used a worm gear and a sliding bar for moving the glass panel.

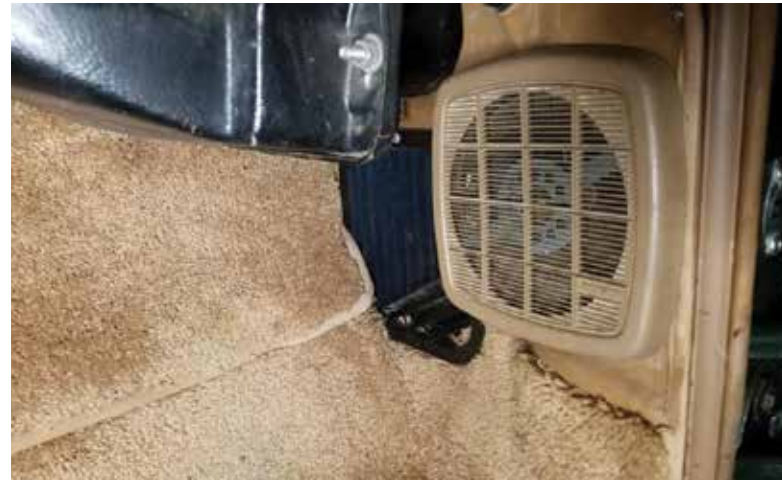
If you want to clean your four drain tubes, two in the front windshield pillars, or "A-pillars", two in the rear sail panels, or "C pillars", Here's how:

1. Remove both of the black fresh air grills (3 screws each) from the kick panels. Move both fresh air controls forward. The doors will now be open, remove the cable from the door and lift up on the door, which will remove it from the lower pivot hole. Push the door towards the outside of the car. The door will now come out of the upper pivot hole. Remove the doors. Reach inside and you will find a plastic tube, that is attached to the inside of the cowl. Pull the bottom towards you and take compressed air and blow into the tube. The air and debris will exit in the front corners of the steel housing. If you blow from the top, down, it can jamb debris in the plastic tube. These tubes make some rear sharp bends, snaking down the windshield pillars.

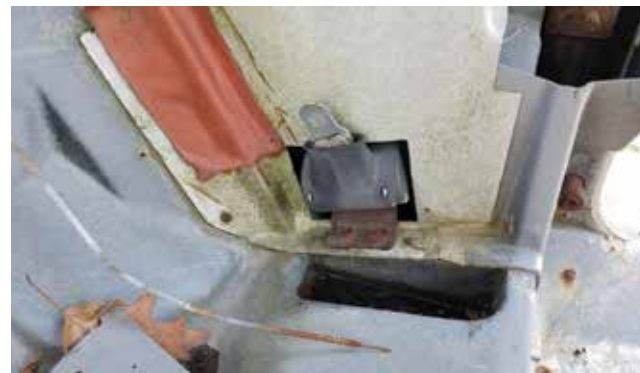
2. For the rear drain tubes, remove the back seat bottom, it just lifts up and out. Remove the 2 outside rear seat belt retractor bolts and remove the seat belt retractor. Reach inside and you will feel a plastic drain tube. Pull the bottom toward you. Take compressed air and blow into the tubes. The air and debris will exit in the back outside corners of the steel housing. Open your sunroof or moonroof (removing is better) and keep blowing out the housing and keep repeating the process for cleaning out your drain tubes, until its all cleaned out. Reinstall the removed parts.

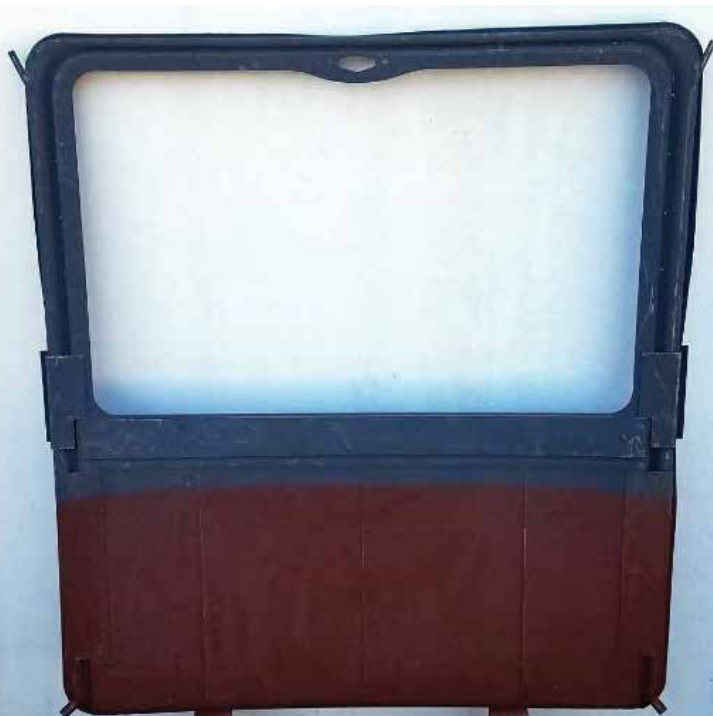
Please notice in this picture, the drain tube nipples, located at each corner

The steel housing is made up of many pieces, that are welded together. These housing were never painted. They only had some kind of primer coating. These steel housings are know for rusting out in places that you can't see, until you remove them from the car.

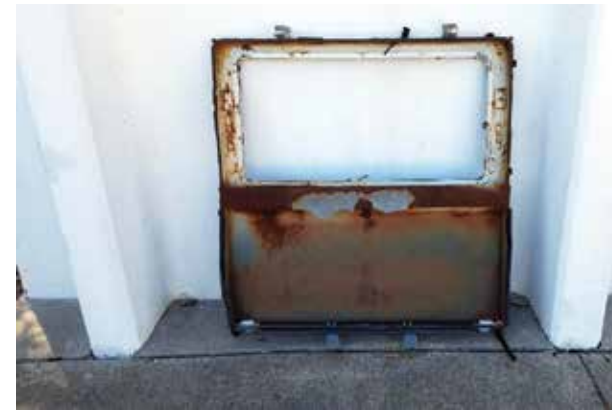
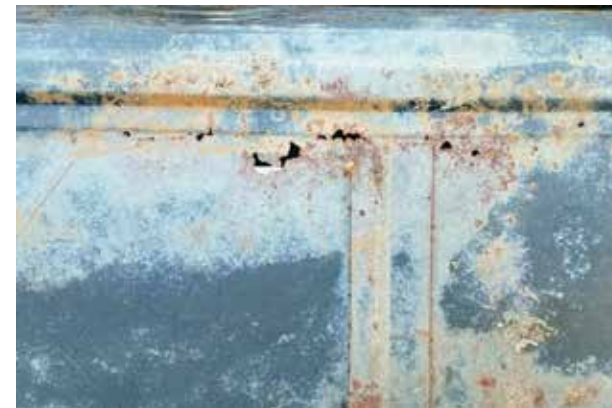
I removed this Sky Top housing about 6-7 years ago. The owners really wanted me to rebond the housing to the roof skin. I talk them out of that and told them the housing could be rusted through, in places that I cannot see until I get it out. His was rusted through over the roll bar, where it is impossible to see. If I had rebonded this car it would have still leaked. I have seen countless numbers of Avanti that have had the steel or glass panel sealed closed with silicone, windshield urethane and etc.
