NOSTALGIC MOTOR CARS UNLOCKS THE HISTORY & MYSTERIES OF THE 1963-1985 AVANTIS

How to Cool Off a 1963-1985 Avanti in an Emergency

By Dan Booth
Nostalgic Motor Cars

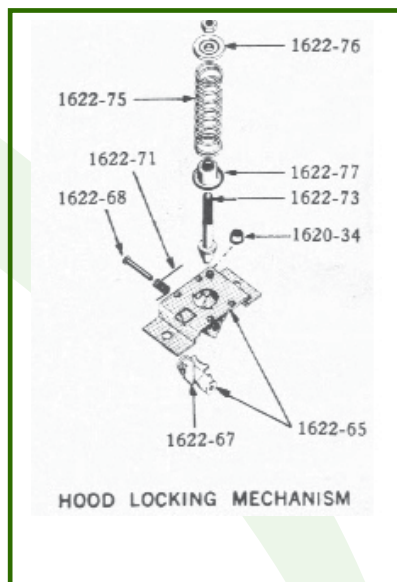
Hood Dove Tail

Hood Support

Hood Hinge

The blue arrows, above, are pointing to 1/8-inch holes I drilled in the fiberglass hood inner support panel. These holes are in line with the bolt threads, sticking out of the top of the nut, which is welded to a plate. This assembly is called a nut plate.

The holes allow you to spray your favorite penetration oil (with a straw on the can) on the threads (below photo). I push the can straw into the hole, until I hit the threads and give a small squirt of penetration oil. I do this on the 4 hood hinge bolt threads, 2 hood support bolt threads and the 2 hood lock dovetail threads. I now close the hood to keep the oil on the threads and nuts. I do this quite a few times over a couple of days.

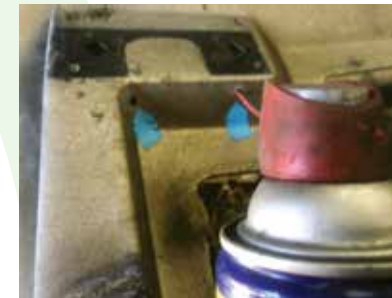
When I am removing a bolt after about 1/2 turn I will run the bolt back in. Squirt a shot of penetrating oil back on the threads. I keep doing this until the bolt is out. After the bolt is out, I clean and oil the threads. I then run a tap in the nut plate, for each hole.

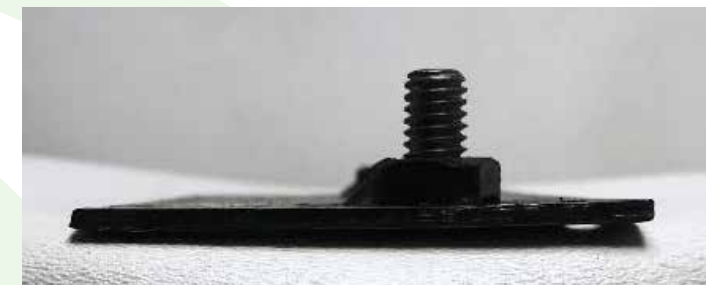
This picture, above, shows the end view, of a hood hinge nut plate with a broken bolt. This is the profile of the slot that must be made to replace the broken nut plate.

A slot for a hinge nut plate can be cut into the vertical front of the hood inner support. The slot will reassemble the old nut plate with a notch in that slot for the welded nut and the broken bolt to come out. After you remove the old hinge nut plate, insert the new nut plate and align the 4 pop rivet holes. Install the bolts and tighten them down. Install the new pop rivets and then repair the fiberglass. See "Nostalgic Motor Cars Unlocks the History and the Mysteries of the 1963-1985" in issue #192, page 44, of the Avanti Magazine, or go to our web site: NostalgicMotorCars.net, click on "Tech Articles", twice.

This would be the same procedure, for repairing the hood support, nut plate or the hood locking dove tail nut plates.

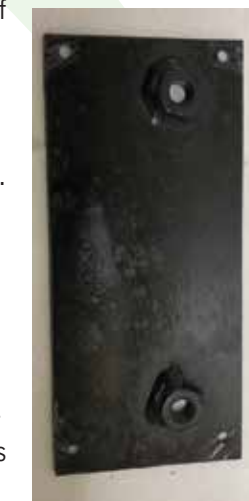
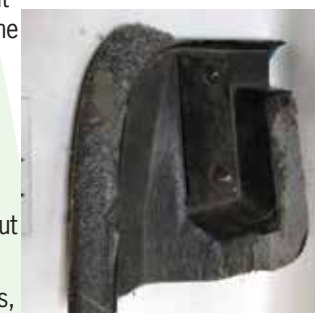
TOP AND MIDDLE: : Nut plate that is riveted inside the hood.

ABOVE: Inside the hood showing the nut plate that the hood hinges bolt to.
