NOSTALGIC MOTOR CARS UNLOCKS THE HISTORY & MYSTERIES OF THE 1963-1985 AVANTIS

1963-'64 Studebaker Avantis Should NOT Leak Water!

By Dan Booth
Nostalgic Motor Cars

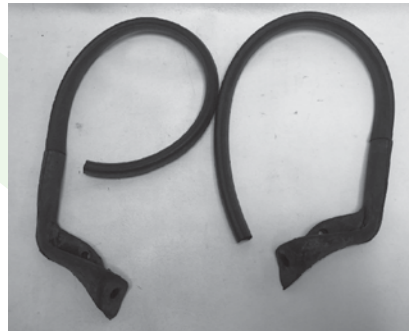
N.O.S. Dog Leg part number 1350856 or 1350857, \$55 each. Sold in Pairs Only

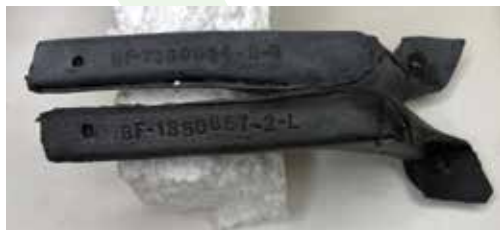
Studebaker designed the Dog leg molding, at left, Illustration # 2116-24 weather seal as a glued together, two piece seal, for good reasons.

The N.O.S. bottom dog leg part has the original part numbers formed on the inside edge, that faces the interior. The dog leg part is made of a very firm, or hard rubber, with two holes for the screws. There is a flat brass washer that's placed in the mold at each screw hole, before forming the dog leg. The very hard rubber is needed as a properly adjusted door has to slide snugly against the door's back edge and the dog leg to keep water out. This part of the weather seal does not have to be compressed, so it needs to be very firm. If the weather seal dog leg is not made with the proper blue print durometer rubber and correct dimension, it will not stay glued and wants to pull away as the door is closing and opening, which in turn, seals out nothing.

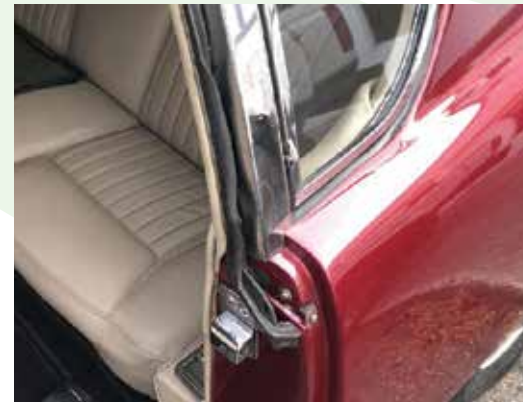
Reproduction one-piece Dog Leg Weather Seal.

Many dog leg rubber reproduction weather seals using the original part number 1350356 and 1350357 are made of a very soft rubber and are a one piece design, not two pieces like the originals. As the pictures shows, the one piece soft rubber doesn't seem to hold it's shape and stay glued to the B-pillar, so obviously it doesn't seal very well.

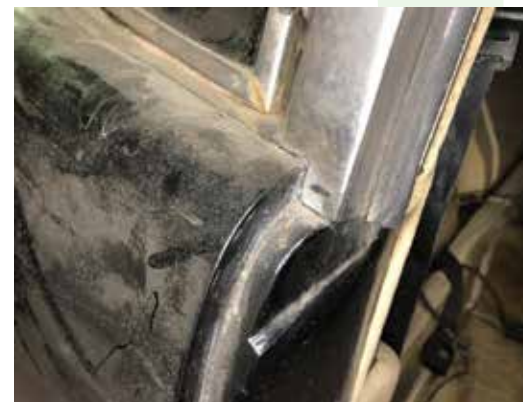
The dog leg weather seals illustration numbers 2116-24 and part numbers #1350856 and 1350857 were changed about half way through the 1983 Avanti model run.

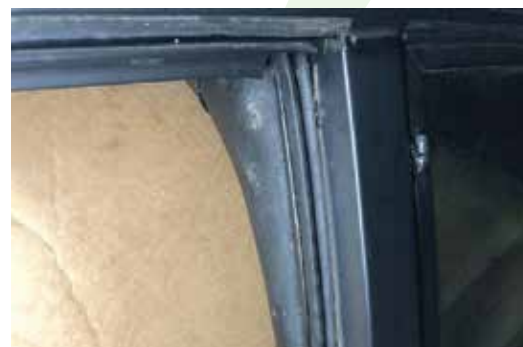
The changes made to the two piece seal was the upper part was no longer a sponge type rubber.

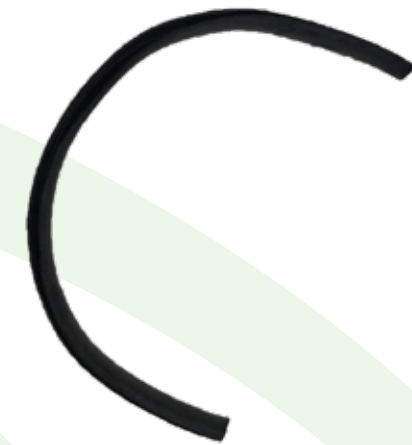
The upper sponge type weather seal, (Part # 1350856-84 1350857-84 \$20.00 each) was installed and ended at the bottom edge of the stainless B pillar trim, Illust#2124-64 P#1350880 and 1350881

It now was a V-shape hard rubber. The V faced, touched the stainless door glass frame. It was not compressible in any way shape or form. Its ability to seal out water and wind noise, was questionable. This proved in a very short time, to not be a well thought out change and was again, changed for the 1984 (about) model run.

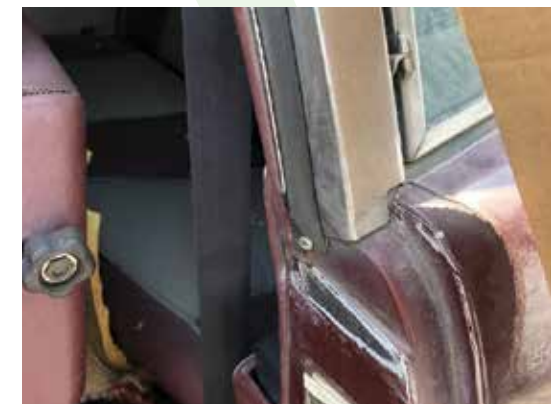
This too, proved to be not well thought out, as a second change was made. It was now a little longer, going down into the painted door jamb about one-inch, and a screw was put through the top of the rubber at the very bottom of the sponge strip.

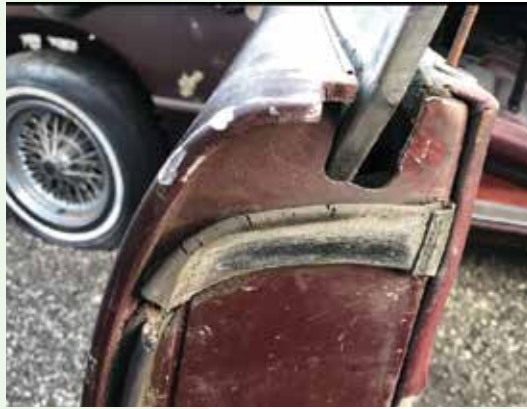
Above is a V-shaped upper dog leg weather seal.

The dog leg part of the original two piece seal was replaced. This was an idea, that looked good, but didn't work very well. They simply cut and glued a short piece of the door surround weather seal, Illustration number 2116-25, part numbers 1350764 and 1350765 to itself, then to the back side of the painted door. They also glued a thinner piece of rubber to the top of the extension that was in turn glued to the door Behind the door panel. As I stated, it looked real nice, but was very questionable on it's ability to seal out water.

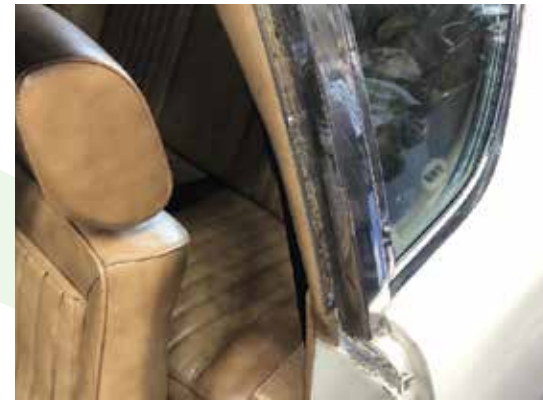
Stainless and Recess for Dog Leg Weather Seal

Remove the old weather seal and most of the old glue, from the painted door jamb and the stainless B pillar cover.

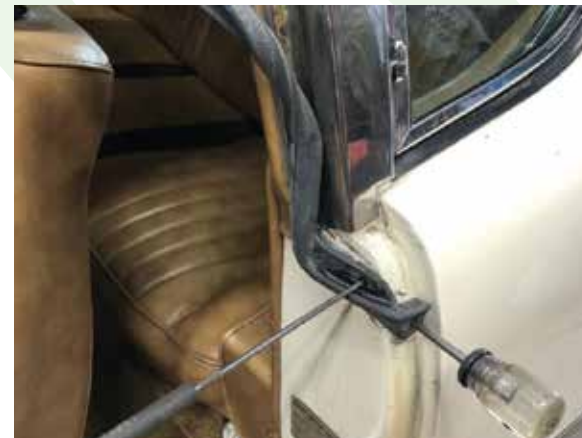
If you look at the painted door jamb, just below the bottom of the stainless cover, you will see a step in the fiberglass, where the dog leg will be located.

Once you feel the weather seal is in the correct location, put a scratch awl in each hole in the dog leg. If the scratch awls don't go into the two existing holes, in the door jamb, the holes might have been drill in the wrong location, for whatever reason or it could have had a reproduction weather seal that was not made from the original blue prints installed.

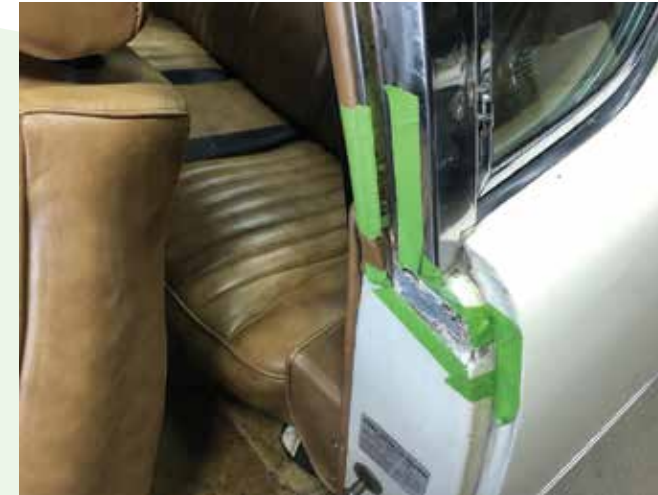
Mask off and mark door jambs.

With two scratch awls in the pre formed holes in the dog leg. Take a magic marker and trace around the edge of the dog leg. Mask off the area to be glued, clean this area and the weather seal.

Brush glue in the taped off area and the back side of the dog leg. Let it flash off. Then use the two scratch awls to locate the weather seal holes for the holes in the door jamb. Once the dog leg is in place, put the two screw in their holes.

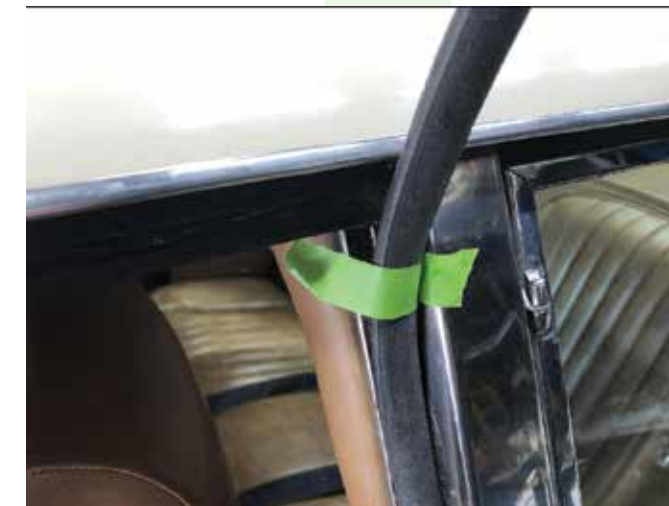
Upper Dog Leg Weather Seal

If you study the upper sponge part of the weather seal, you will see it has a step on the back side. The step fits into the channel on the stainless pillar cover. It must lay totally flat in the channel, and glues over the three screw heads.

You will notice, as you place the upper part of the dog leg weather seal in place, that it is too long.

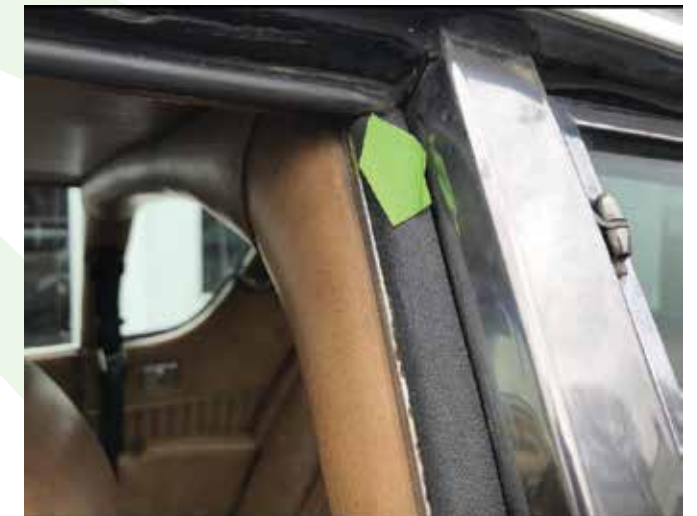
Upper Door Weather Seal Hole Location at the Top Back

You must poke this weather seal up into the preformed hole that's in the upper door weather seal illustration #2116-22 part numbers 1351334 and 1351335. Shorten the weather seal, until when it pokes up into the hole, it will be flat and straight.

Mask off the stainless, so you can brush glue in the channel. Then brush glue on the back side of the sponge seal. After the glue has flashed, place the seal in the channel, then poke the end into the hole in the upper weather seal.
