How to Prevent Your 1963-1985

Door Panels from Warping

Avanti Repair

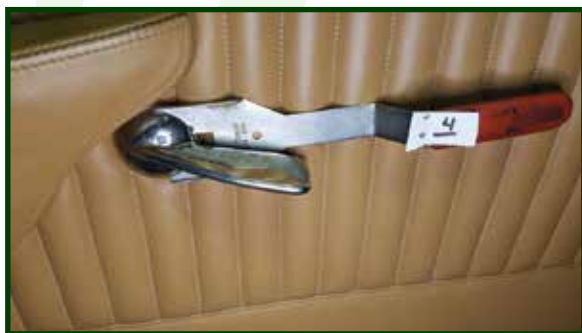
If you have never removed an inside door handle, or window crank handle, this is what you will be doing pushing out that clip see photo below. If you don't have one of these tools I have them in stock for about \$5.00.

Remove the inside door handle with the door handle clip remover (photo#4).

The removal tool will push out the horse shoe retainer clip from a slot. The open end of the horse shoe clip should be facing the long end of the handle, if it was installed correctly. After the clip is removed, the handle will pull straight off. Remove the window crank handle (if you have manual windows) with the same tool. If you have a 1970-1984 Avanti with the door pull strap photos #5. Remove the 2 chrome caps and then remove the 2 screws. If you have a 1985 Avanti with the arm rest and pull handle as a unit then remove 3 screws. Remove the screws that secure the door panel to the door. Lift the door panel up and off.

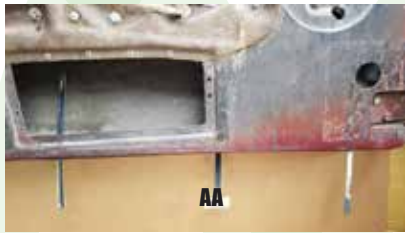
There are 4 water drain slots in the bottom of all 1963-1985 Avantis. If the door is dry on the inside, I vacuum and blow out the inside of the door. I then slide a hack saw blade up through the 4 - 2½" long slots on each door bottom. Then blow up with compressed air through those 4 slots.

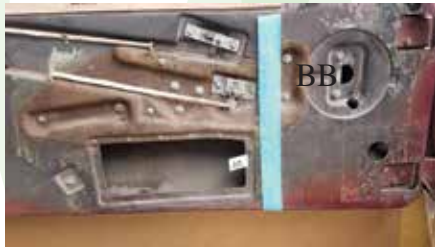
Avanti Motors Used to give me a roll of what appeared to be black masking tape, about 8" wide for warranty repair. That covered the access hole in one piece

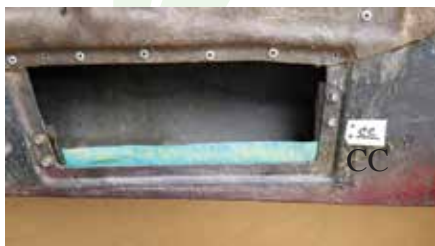
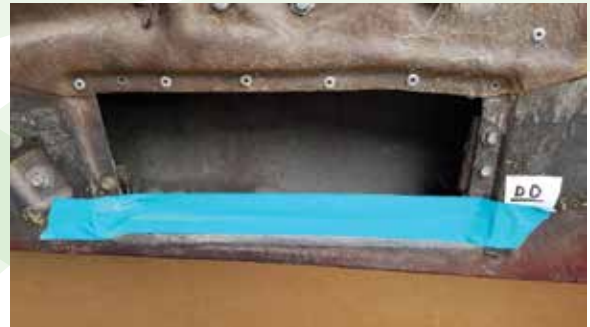
I use 2' wide masking tape. The first layer of vapor barrier I stick to the door (photo BB), and spray glue over top of the original glue. Let it flash a little then place it in the bottom inside of the access hole, Photo CC

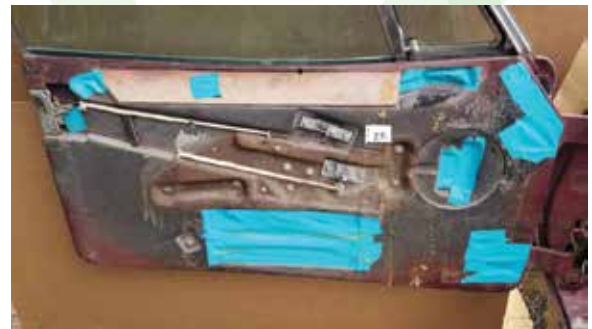
I apply spray glue to all the 2' wide tape as I am installing them. Start at the top and work your way down overlapping about 1/2". It's super important to completely cover the bottom inside the first piece you installed.

Tape up the remaining holes, and you're ready to reinstall the door panel.
