How to Replace a Broken Front Floor Nut Plate on Your Front Seat

How to Repair a broken front seat track nut plate

Avanti Repair

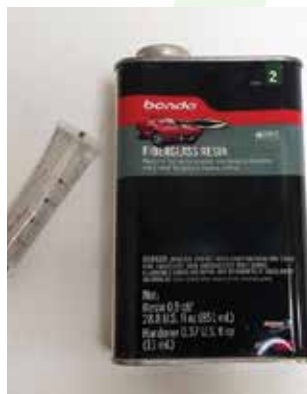
1963-64 Studebaker Avantis and all 1965-85 Avantis have nut plates, part # 1351038 riveted to the floor pan in the raised area below the front seat. These nut plates are located on the bottom side of the floor pan. This raised area of the floor pan has a flat piece of fiberglass bonded and riveted to the bottom side for added strength, which hides these nut plates. Being exposed to mother nature for 35 to 57 years, has caused the 5/16"-18 threads to rust and the bolts normally break off. This is actually a very common problem, but easily repaired to factory specs.

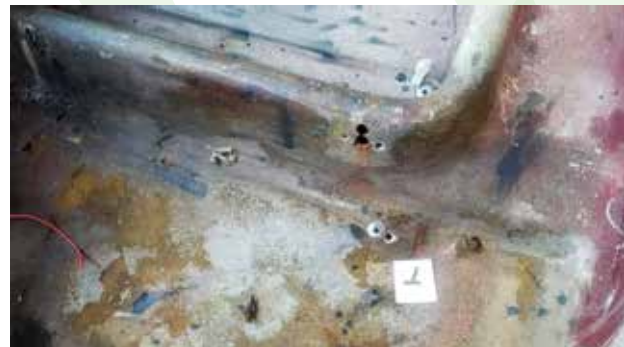
Drill out the old small pop rivets, that were countersunk

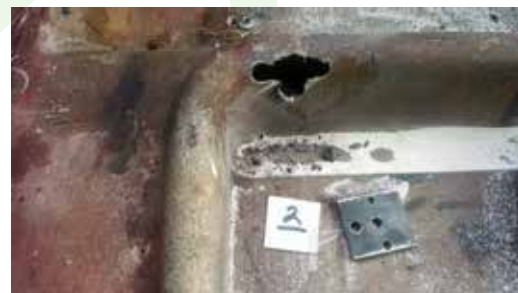
Grind a slot in the back side of the raised area, about the same size as the new nut plate. You will also have to grind a perpendicular slot so the old nut plate will come out, with the broken off bolt (see photo 2)

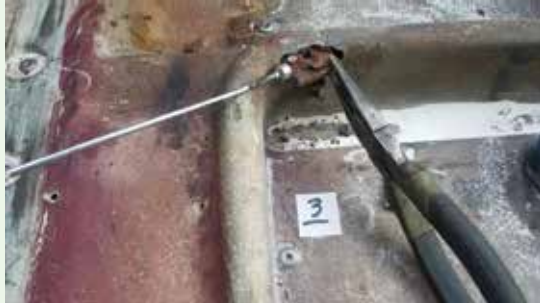
Take your magnet to retrieve the old nut plate, and pull it out with our needle nose pliers.

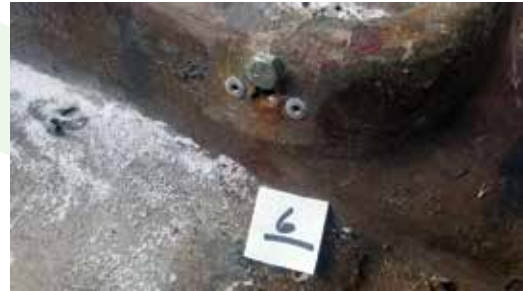
Drill the new holes through the fiberglass for the new larger pop rivets. You may have to remove the lower bolt for clearance for the pop rivet gun.

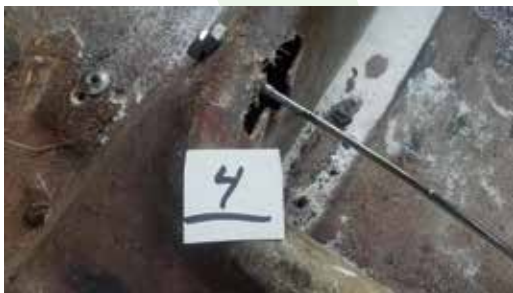
Load the new nut plate on the magnet, stick it through the hole, use your scratch awls to line up the bolt holes. Start a 5/16" bolt in one of the holes, then start the 2nd bolt. Use your scratch awls to line up the rivet holes, then tighten down the bolts.

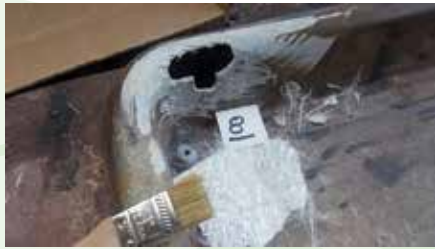
Cut some fiberglass mat large enough to cover the repair, each layer a little larger than the previous, about 2-3 layers of 1½ oz. mat. Cut your 1" paint brush bristles to about 1/2" long. If you can't find the fiberglass mat, I have it in stock and can cut what you need.

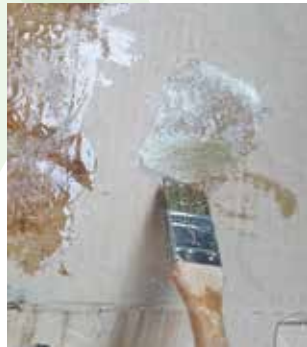
Mix your resin with your catalyst. I pour some mixed resin on a piece of cardboard, place a piece of mat in that poured resin, and then turn it over to get the mat completely wet with resin. I place the piece of wet fiberglass mat on the surface to be repaired, stretching it out. Using the shortened brush, I lightly jab (stipple) the fiberglass working towards the edges to get any air bubbles out. I repeat this process again for the 2nd layer. Each layer of mat should be just a little bigger than the previous layer, so the thickness tapers. Repeat for the 3rd layer, don't apply too much resin, just enough to saturate the layers of mat, stippling each layer of mat to get any air bubbles out.

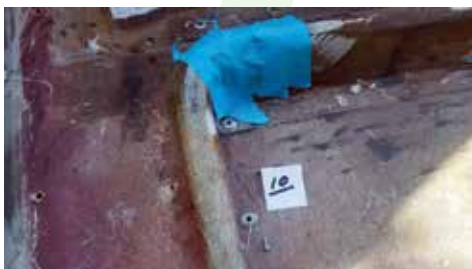
Take 2' wide masking tape and carefully place it on the repaired area. I keep overlapping the masking tape (see picture #10, until I have covered the hole area. I then take my fingers, a spatula, a small roller, a cut off new paint brush and etc, working from the center to the edges leveling and working the air out. I keep watch on my repairs, I remove the masking tape from the center out, when the resin has almost fully kicked. Make sure when you are removing the masking tape, that it is not pulling the new fiberglass mat away from the original fiberglass.

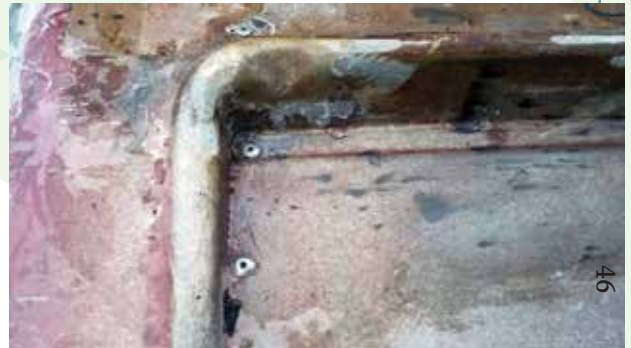
This is what your repair will look like, when your are finished. A little scuffing with some 80 grit paper to knock down any pointed or sharp fiberglass threads, and you are finished with this repair.

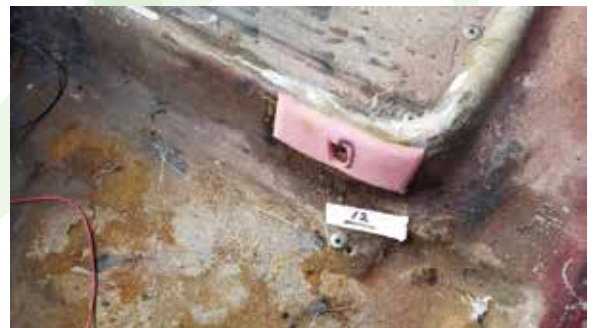
Take 1/4" foam rubber about 2" x 4", or the size of your choice, cut a hole for the 2 5/16"-18 bolts and glue it to the floor. I take a grinder or a new single edge razor blade and taper the edges of the foam. This glued on foam will keep the pop rivet heads from showing through the glued on vinyl, which was installed on 1963 Studebaker Avantis. If you have an Avanti where the entire floor was covered with carpet, including this raised area, you will not need to install this foam.
