NOSTALGIC MOTOR CARS UNLOCKS THE HISTORY & MYSTERIES OF THE 1963-1985 AVANTIS

Don't Break Your Avanti Door Glass !

The deterioration of the left and right door window lift channel can lead to very expensive repairs, if not corrected.

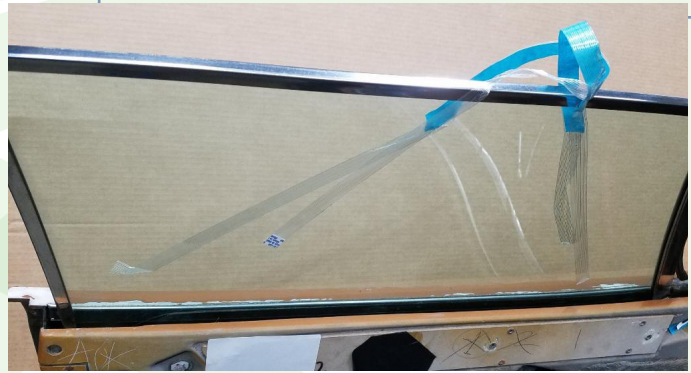
Take some nylon filament tape and tap it to the glass on angles. This gives you a handle to pull the glass up and out of the door. Don't trust this tape handle after the glass is removed. The blue tape is stuck to the sticky side of the filament tape, so it won't stick to my hand.

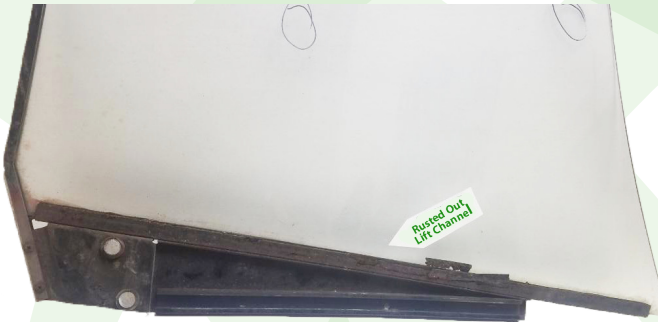
Steel Channel part #1857x1 (Which is rusted out)

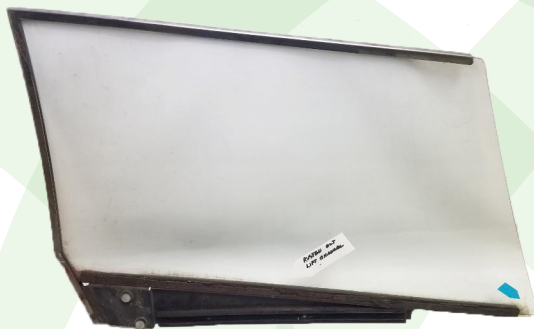
The white arrow is showing the rusted out lift channel 1857x1 which isn't capable of holding the glass securely in the lift channel anymore.

Measure the distance (blue arrow) from the edge of the glass to the end of the rusted lift channel part#1857x1. This dimension will be used to reassemble the glass back in the shot gun assembly

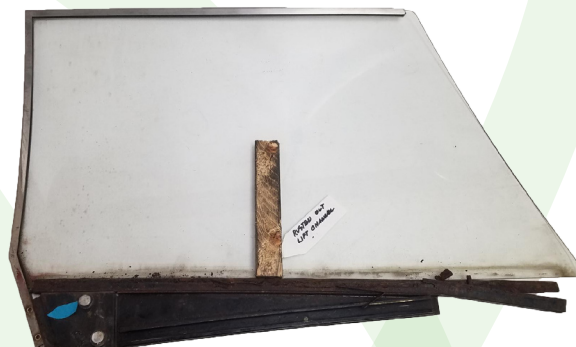
I now take a wooden block and tap down on the shotgun assembly to free it from the glass. Then grind the 2 screws flush with the steel shotgun assembly and take vise grips to grip the threads and remove the screws from the back side.

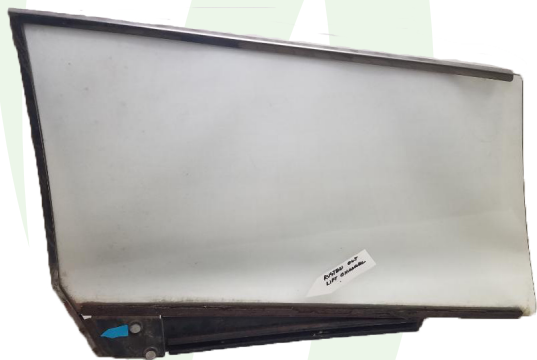
The blue arrow is pointing to the 2 Phillips head screws that need to be removed. These 2 screws very seldom will come out without heating them up and then the Phillips head strips out. What I normally do is grind off the Phillips head flush with the stainless frame illust#2120-3 Part #1350728/729

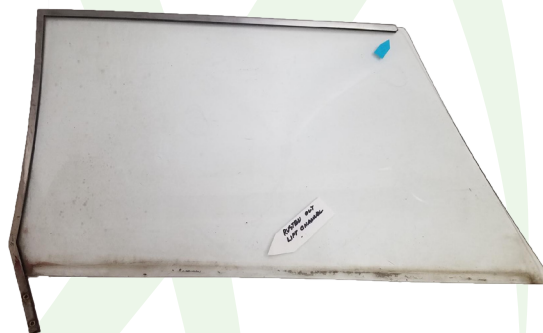
Make sure that the stainless frame, illust # 2120-3 is still gripping the glass very tight. If it's just a little loose on the glass, it will only get worse. Eventually the frame will hang up on the top of the vent frame and come off the glass, which leads to a bent frame and or broken door glass

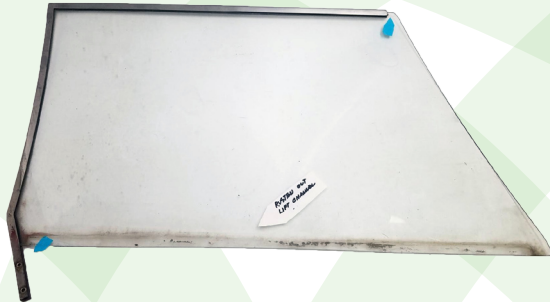
The cushion strip is easy to change now as the glass and frame are separated from the shot gun. If you are going to change the frame cushion take measurements, where the 2 blue arrows are. Measure from the edge of the glass to the stainless at both locations.

These measurements will be used when the stainless is reinstalled on the glass with a new cushion strip.

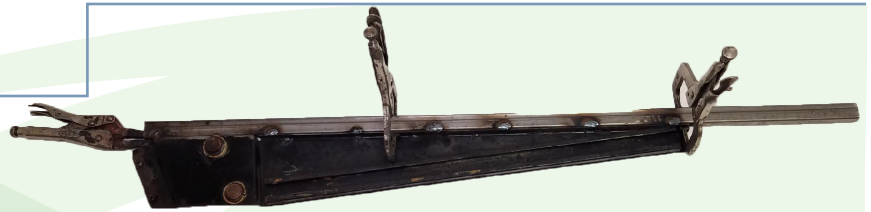
This is a shot gun with the rusted channel removed and the new channel clamped in place and welded.

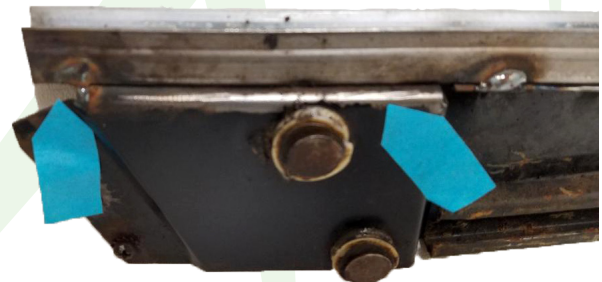
This photo shows that if the outside was flush then the inside should be 1/8" offset on only the area that has the roller slide guides. It also shows that the channel should extend about 1/2" over the section with the roller guides.

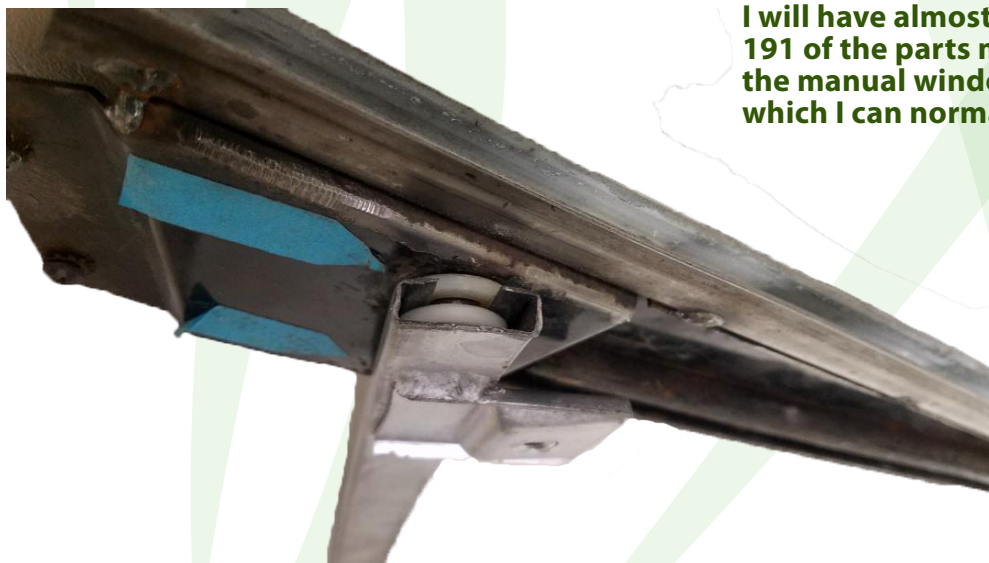
This photo shows how the slide guide nylon washers are installed correctly in the window guide, Illust # 2120-52 part # 1350487. The window guide should have grease, in it's entire length, on the inside and outside of the guide. The purpose of the wave washers is to keep tension on the nylon washers

The greased C channel will have a white nylon roller on the inside and one on the outside. The outside also has a wave washer, please study photograph.
