Could your 1963-1980 Avanti quit moving in the middle of a busy intersection, or when you are passing another vehicle ?

By Dan Booth
Nostalgic Motor Cars

Avanti Repair

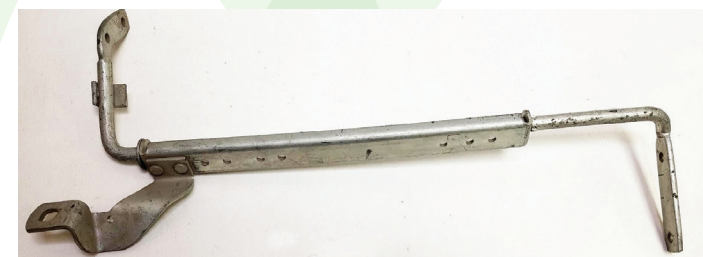
1547836 Very Rare N.O.S. Accelerator Bell Crank

Most of the time these bell crank throttle controls will have a lot of play in the 2 formed pivot points. (one on the top and one on the bottom) where the main shaft pass through the main bracket. There should be no more than about .005 play side to side. A normal sheet of paper is about .003 -.005 thick If the two pivot points have wear, when you press the accelerator instead of moving the throttle, that shaft will first move sideways in the pivot holes before the responds to the carburetor. Then when you return to idle, it will not respond correctly and makes the car idle higher than normal until you hit the accelerator fast and hard to force it return properly. Some owners or mechanics just install a much heavier return spring and think that fix is it. All that does is kill your angle from too much resistance and the wear factor only increases. The very rare N.O.S bell crank throttle control # 1547836 is \$195.00 while supplies last.

The next very rare part is a N.O.S. Bellcrank throttle control Illustration # 0312-15 Part # 1547836 The bell crank was installed on all 1963-1964 Studebaker Avantis This part 1547836 is N.O.S. but doesn't have the 2 mounting bracket. You will have to transfer your old brackets or you can send me your old bell crank and I will transfer your old bracket to the N.O.S bell crank for time and material

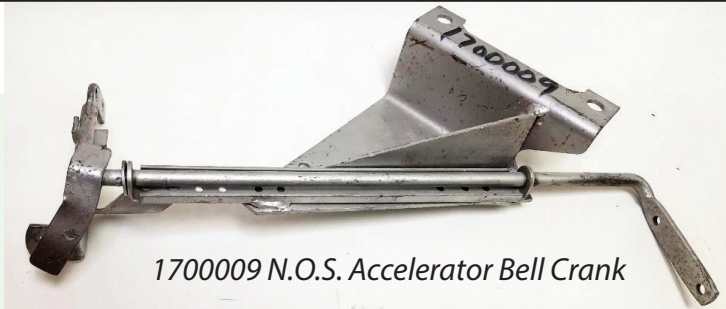
1700009 N.O.S. Accelerator Bell Crank

The second style bellcrank throttle control is 1700009 this was installed on all 1965-1974 Avantis. This bell crank 1547836 was used on the 1963-64 Studebaker Avantis but with different welded mounting bracket to fit the Chevy engine and a lever welded to the top to activate the trans kick down switch. This bell crank 1700009 has exactly the same wear points as the 1963-64 Bell crank and should only have about .005-inch clearance, side to side play. So you might want to reread the description, from 1547836 in the previous paragraph. This is a very rare N.O.S. bellcrank throttle control #1700009 and is \$195 at the time of this article, and while supplies last.

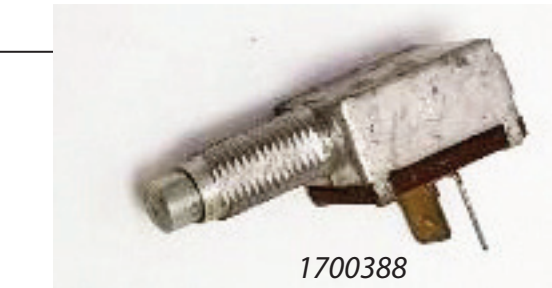
1700388 Accelerator solenoid kick down switch This N.O.S accelerator solenoid kick down switch 1700388 was installed from 1970-1980. For 1970 through 1974 this switch was installed in the top D shaped hole in the top of the 1700009 bellcrank. For 1975-1980 this switch was installed in 2 separate brackets Part #1701092 and 1701093 which were bolted together. Then they were bolted to the intake manifold with the back left bolt. The switch was now facing straight up through the D shaped hole. the N.O.S. switch 1700388 is \$50.

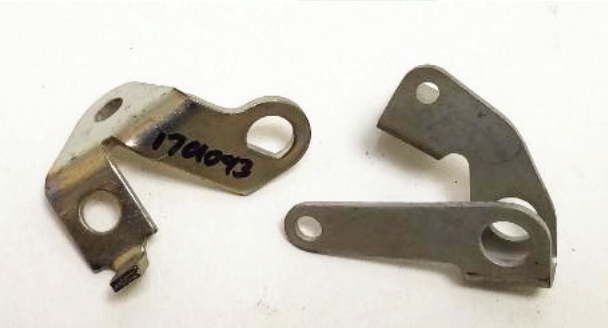
1701093/092

Kick down switch brackets 1975-1980 These N.O.S. kick down switch bracket are 1701092 is \$20.00 1701093 is \$20.

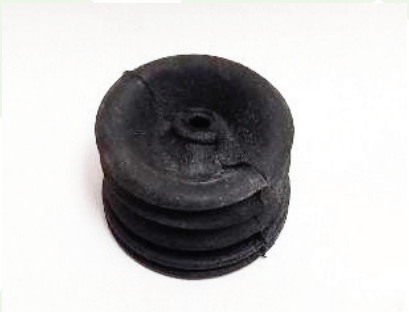
The next possible problem is the accelerator push rod sleeve Illustration #0312-5 part number 513536x1 These N.O.S sleeves are \$6.50 This is very simple as the hole in the sleeve wears larger and/or the push rod illustration #0312-5 part # 1556160 has built up crud on it where it goes through the rubber sleeve. Just simply clean off the crud and put a little grease on the rod. And replace your rubber sleeve with a N.O.S one.
