Is your Avanti REALLY Safe to Drive?

How To Replace the Steering Flange and Insulator (Rag Joint)

How To Change a NOS Avanti Rag Joint from 1963-1985

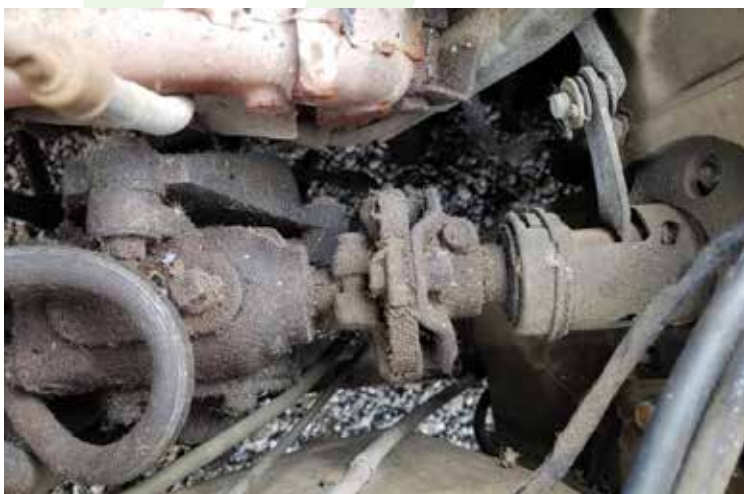
New Original Stock Rag Joint #1701886, Installed with jumper ground wire

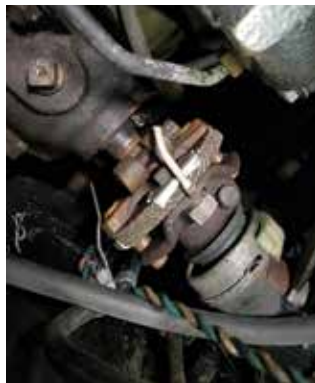
This rag joint #1557139 was installed on all 1963-1964 Studebaker Avanti and all 1965-1981 Avantis. Avanti Motors redesigned the rag joint for about the 1982 Avanti to part # 1701886. The big change was to eliminate that pesky brass horn contact strip that was breaking. The new design has a screen material in the top layer of the rubber for the horn contact. To make sure that the screen material would not fail after years of use. They added a white jumper that jumpered from one flange to the other flange.

White jumper ground wire.

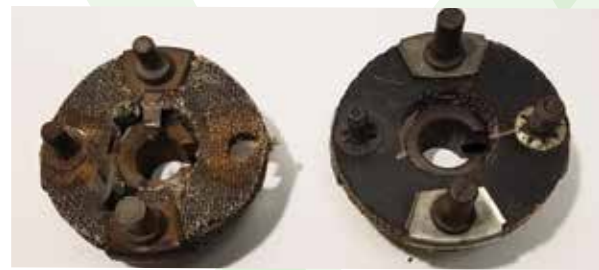
The pictures show a NOS rag joint #1701886 and a rag joint I removed form a 1981 Avanti (39 years old). This 1981 was shipped to me with a little play and vibration in the steering, that nobody else could figure out what was wrong. I decide to change the rag joint, knowing there was no play that I could see in the rag joint. The NOS rag joint solved the problem of play in the steering.

I inspected the old rag joint. I took out one of the attachment bolts from the rag joint and noticed that the hole was becoming elongated and split on the outside of that hole. I further flexed the rubber and noticed it cracked at the edge of the steel retainers. In the photo, look at the fuzzy threads that show where the hard rubber and fabric are cracking, breaking and tearing, and etc.
