NOSTALGIC MOTOR CARS UNLOCKS THE HISTORY & MYSTERIES OF THE 1963-1985 AVANTIS

The Avanti Exhaust Systems

One of the most difficult systems to install correctly

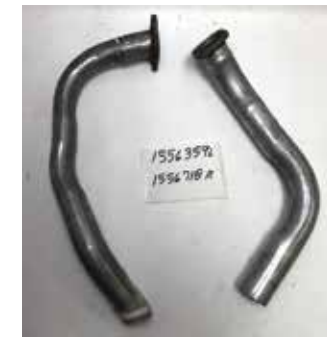
R-1 / R-2
1556359 L
1555718R
Aluminized or Stainless

Studebaker's 1st pipe (head pipes) have a flange welded to the pipe that bolts to the exhaust manifold. It has absolutely no adjustment, up, down or side to side.

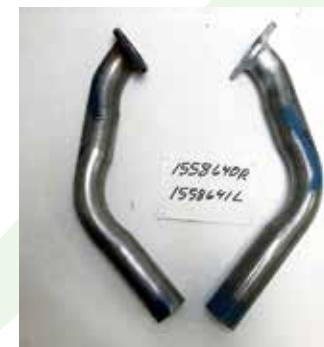
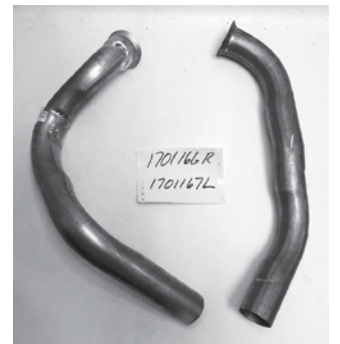
R-3 / R-4
1558641 L
1558640 R
R-3 / R-4 pipes
Aluminized or Stainless

1701166 R 1701167 L
with 2-inch exhaust manifold, aluminized or stainless 1966-1974

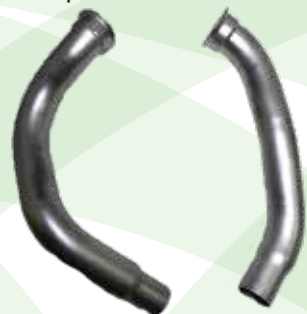
With 2 1/2" exhaust manifolds plain steel

The 1st pipes 1700066 and 1700067 were installed on the 1st Avanti II's produced with 2 1/2" exhaust manifolds.

N.O.S. 2 1/2" exhaust manifolds, 1st pipes, heat risers, angles in stock Sold as a kit only this N.O.S. kit will fit 1965-1985 Avantis

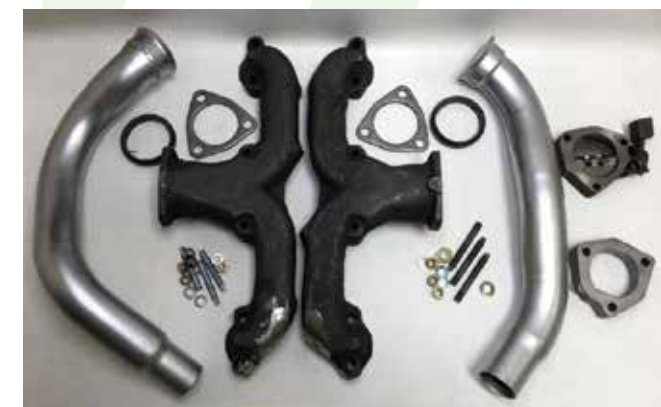
The early Avantis produced by Avanti Motors were produced with 2 1/2-inch rams horn exhaust manifolds and 2 1/2 -inch 1st pipes.

You could also order your new Avanti with 2 1/2-inch exhaust manifolds, through the end of the 1974 production run. Avanti Motors parts department offered all the components to convert your Avanti to the performance 2 1/2-inch rams horn manifolds. This 2 1/2-inch performance kit part number 1700069 will fit all 1965-1985 Avantis and doesn't have the clearance problems that you may have with the many different aftermarket designed headers

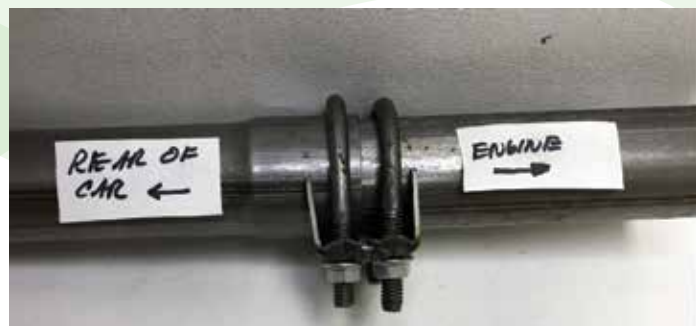
Single clamp on female pipe with other half as support.

Studebaker designed a double clamp Illustration number 0401-22, part number 1547588R, that pinches the 1st pipe (head pipe) to the second pipe. Its purpose was to serve as a clamp to pinch the two pipes together and a support to keep the pipes from moving around.

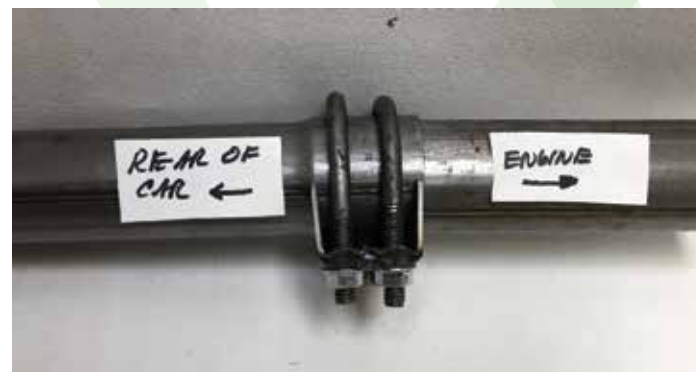
Double clamp on female pipe Two different ways to install the special double clamp.

The double saddle is only over the 2nd pipe only to pinch it in two places. I prefer the first as it holds the pipe and keeps the 2nd pipe from rotating down and I think that's what the drawing shows, you be the judge.

This clamp 1547588 was installed on all 1963-1964 Studebaker Avantis and most all 1965-1974 Avantis. The Avanti system from 1963-1974 was what I refer to as a 5 place exhaust system. The 1st pipe is what some call the head pipe. The 2nd pipe connect the 1st pipe to the muffler which is 3rd. The 4th pipe is the resonator or the resonator eliminator pipe, which connect the muffler to the tail pipe and the tail pipe is the 5th. This 1-5 system makes it much easier to explain your exhaust system needs.

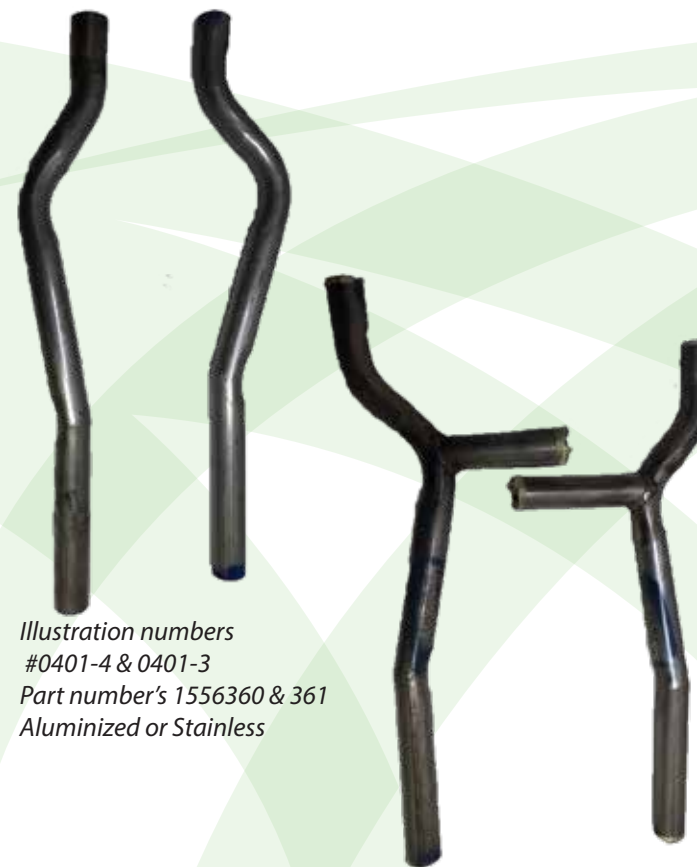
Illustration numbers #0401-4 & 0401-3 Part number's 1556360 & 361 Aluminized or Stainless

Illustration numbers 0401-4 and 0401-3 Part number's 1560001 and 002 \$140 ea.

There were two different 2nd pipes, for 1963-1964 Illustration number 0401-3 Part number 1556360 and Illustration number 0401-4 Part number 1556361 were the standard pipes that connected the 1st pipe to the muffler. There was also "H" pipes (balance pipes), which were installed with quiet tone or glass pack mufflers. The "H" pipe was suppose to give you between 7-15 more H.P., from what I have read.

The big problem was they were very difficult to install on a new Studebaker Avanti with all new parts and almost impossible to make any adjustments to the exhaust system as it snaked through the frame X member.

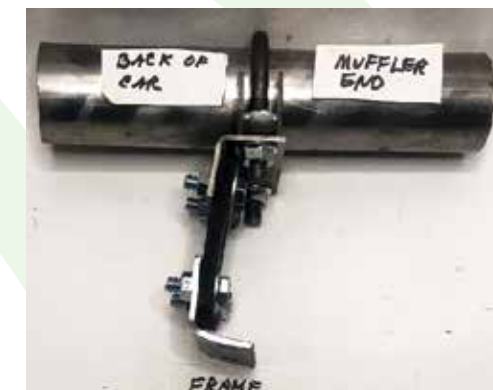
This picture shows the proper placement as they are assembled. All parts of driver side of car.

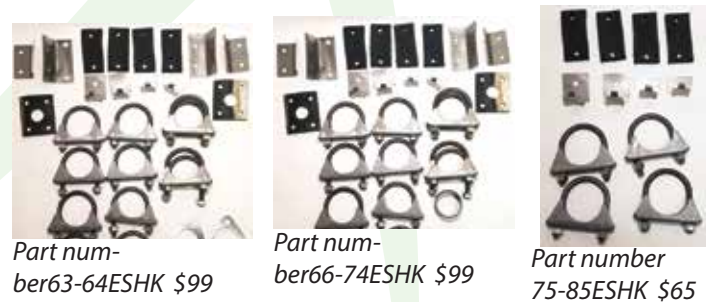
These factory correct kits contain heavy duty U-Bolts and saddles, 2 special double U-Bolt and saddle clamps, special brackets, special single straps, special double straps, special supports and gaskets everything you need except the nuts and bolts for the factory correct installation. Each kit contains the correct parts needed for the specified year of the Avanti.

Nostalgic Motor Cars is also the only one who offers a complete factory correct exhaust system installation kit. These are 3 different kits available.
Part number 63-64ESHK \$99
Part number 66-74ESHK \$99
Part number 75-85ESHK \$65

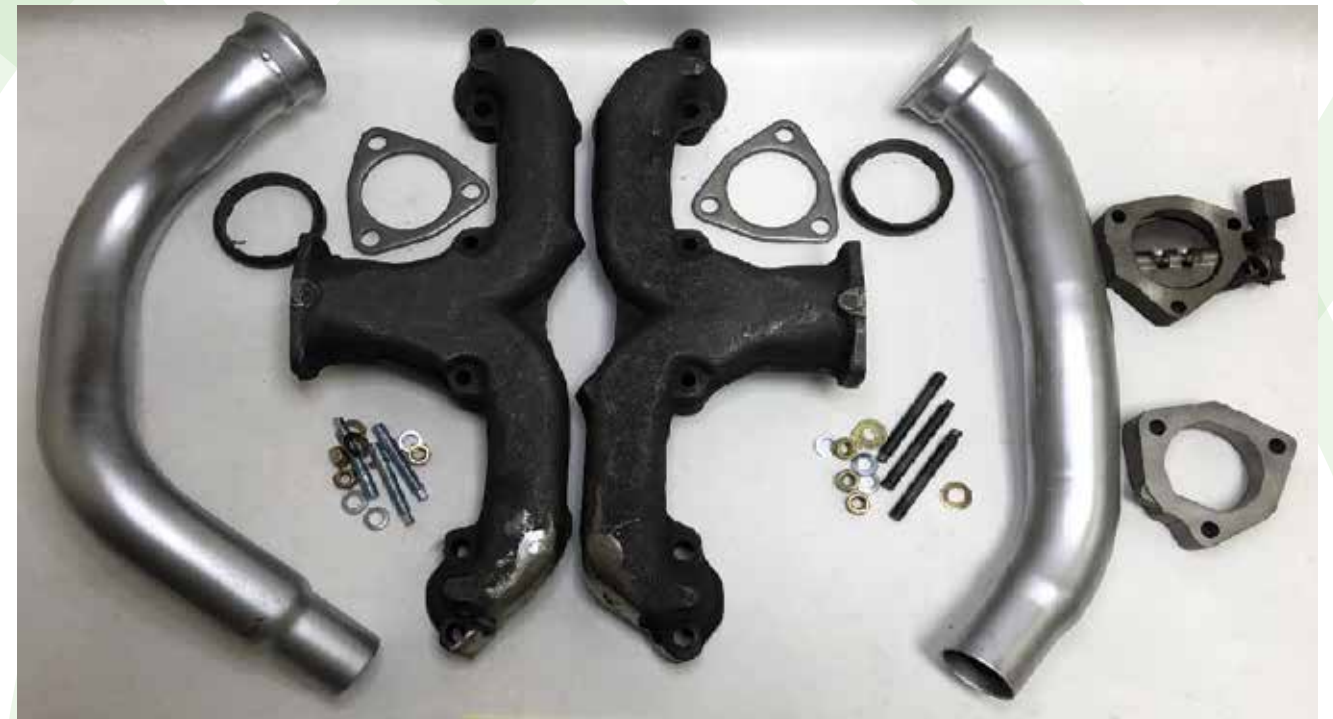
1700069
2 1/2" Exhaust Manifold Kit
High Performance \$625.00

- 1 - Left 2 1/2" Rams Horn exhaust manifold
- 1 - Right 2 1/2" Rams Horn exhaust manifold
- 1 - 1700067 N.O.S. 2 1/2" 1st exhaust pipe left
- 1 - 1700068 N.O.S. 2 1/2" 1st exhaust pipe Right
- 1 - 2 1/2" heat riser or 1 - 2 1/2" spacer
- 2 - 2 1/2" exhaust pipe ange
- 2 - manifold stud kits
- 2 - 2 1/2" donuts
