Next Step: How to Replace a Heater Control Valve In a 1963-1985 Avanti

By Dan Booth,
Nostalgic Motor Cars

How To Change Your 1963-1985 Heater Control Valve

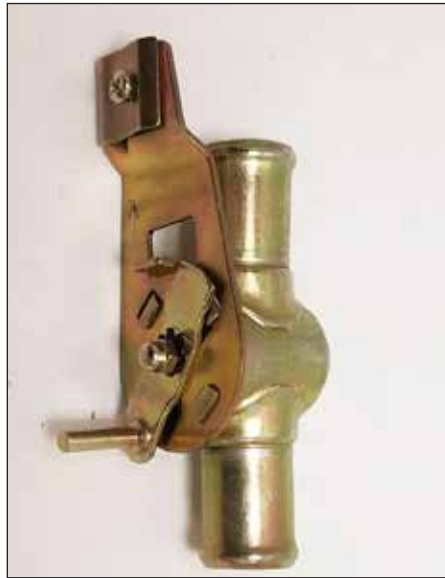
Heater Control Valve #1702189, before it was modified

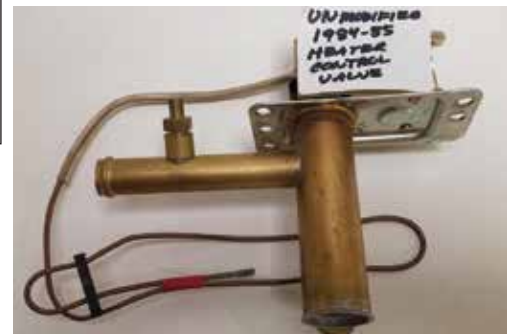
At left: 1702187 factory 1963-1985 Avanti replacement Heater Control Valve

I called him back the next day and told him that I thought the heater control valve was installed backwards. I had to cut off and shorten the tube with the bleeder valve on it, including the bleeder valve. I reversed the holes when I installed the valve back on the car, and it worked. The hammer nose was now gone. Now I had to remove the valve again and make up tooling to install that lip on the end of the tube, which keeps the hose from coming off.

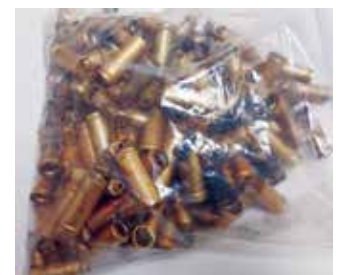
I did modify about 100 new valves. I still have the cut offs, why I kept them, is anyone's guess.

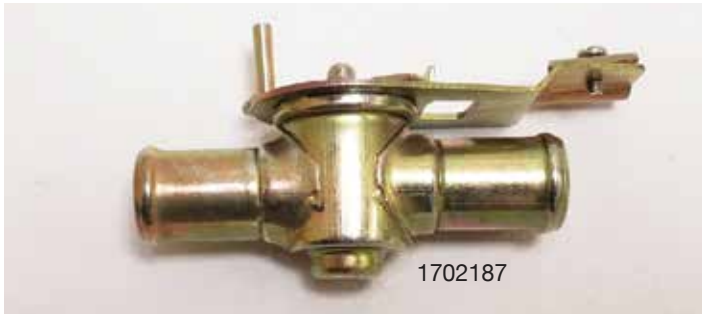
This new service heater control valve, part number 1702187 which I have in stock, will fit all 1963-1985 Avantis and provably fit a lot of

Studebakers. This valve is 3/4" x 3/4" line size to fit 3/4" heater hose. If you have a later model Avanti that has 5/8" and 3/4" size heater hoses. I have the N.O.S. 5/8" x 3/4" reducer in stock part # 1701476 that you will need to hook this valve to that 5/8" heater hose.

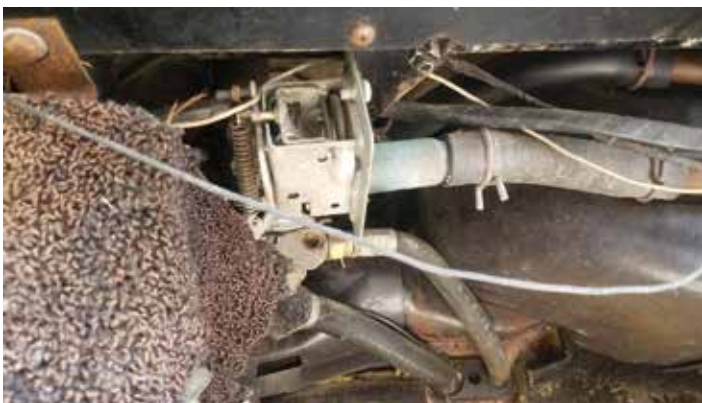
This new service heater control valve, part number 1702187 which I have in stock, will fit all 1963-1985 Avantis and provably fit a lot of Studebakers. This valve is 3/4" x 3/4" line size to fit 3/4" heater hose. If you have a later model Avanti that has 5/8" and 3/4" size heater hoses. I have the N.O.S. 5/8" x 3/4" reducer in stock part # 1701476 that you will need to hook this valve to that 5/8" heater hose.

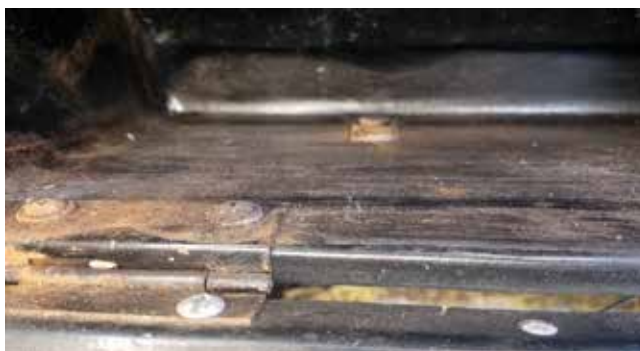
Remove the two nuts that hold the heater control valve to the bottom of the glove box. In the picture if you see the white wire that's crossing over the heater hose. This wire ends at the nuts that you will have to remove.

After you remove those two nuts and after you remove the bracket you can now reinstall those two nuts on the nut plate, or remove the felt liner from the bottom of the glove box and remove the nut plate. This picture shows the bottom of the glove box with the exposed nut plate.

- Remove the control cable
- Remove the hose clamps
- Remove the two hoses and let them drain into a pan, clamp off the 2 heater hoses under the hood at the firewall
- Remove the screw or screws that hold the capillary tube to the heat duct
- Tape up the heat duct hole with H.D. Black duct tape, Gorilla brand duct tap is black and very heavy duty.
- Install the two hoses, clamps and cable
- Add anti freeze and you are done.

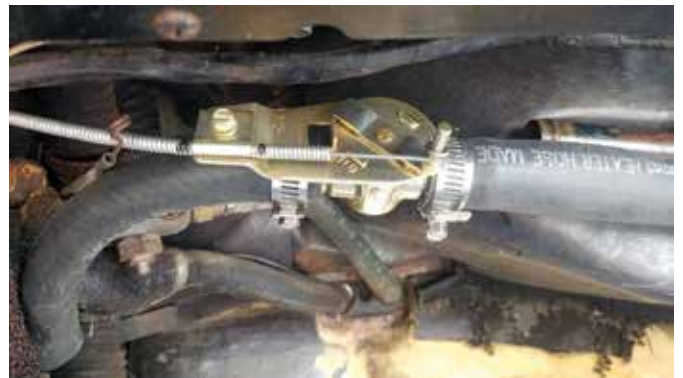
Finished replacement with N.O.S. Parts
