Avanti Repair

Is Your 58 Year Old Distributor, Trustworthy & Reliable?

By Dan Booth
Nostalgic Motor Cars

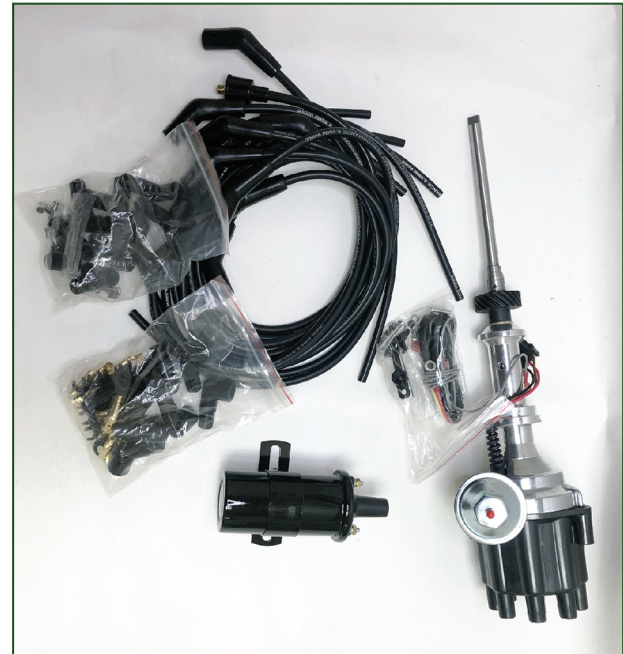
About two to three years ago, I started selling a new reproduction, fully electronic, complete distributor kit. The kit is a complete drop in, with no extra parts to purchase. I assigned the part umber 1557897R. The kit contains; one new complete distributor, one new 45,000 volt coil with a bracket for a hotter charge and better burn. Lastly, one set of spark plugs wires, see picture, this page.

This kit 1557897R will also fit all Studebaker V-8 engines, with 12 volt electrical systems.

I have not had the time to install this outstanding kit in an Avanti yet. What I have told everybody that has purchased this kit is; The new 45,000 volt, high voltage coils are about ½-inch longer than your old coil. The new coil may bottom out against the ignition shielding right bracket Illustration #0603-30 part #1557221 which may keep you from installing the stainless cover (dog house) illustration #0601-62, Part #1556936 Its very close. You may have to install a relief in this bracket, that will allow the coil to slide down just a little. This is an outstanding buy at \$270, for a complete kit that may help restore your Studebaker V-8 engine back its original performance it once had.
