Avanti Repair

Nostalgic Motor Cars Unlocks the History and Mysteries of the 1963-1985 Avantis

This is an Avanti Safety Issue!

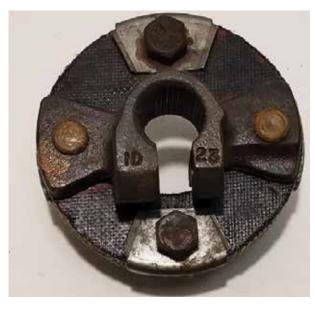
1701886 N.O.S. Rag Joint \$175.00 1700615 N.O.S. Rag Joint Bolt \$5.00

The Avanti steering flange and insulator (Rag Joint) part number 1557139 superseded by part number 1701886 was installed on all 1963-1985 Avanti. It connects the steering column to the steering gear box.

To say it's a very critical part for controlling how your Avanti safely changes direction, when you turn the steering wheel, would be an understatement. It's simply rubber and cotton threads. It's made like they make tires. Would you drive your car with 36-58 year old tires? Probably not, but your steering your car with a 3/8" thick flat donut rubber circle that only 2" away from the left exhaust manifold that's 36-58 years old. To to the best of my knowledge the rag joint #1557139 and 1701886 were made especially for the Avanti
