Mysteries of the 1963-1985 Avantis

By Dan Booth,
Nostalgic Motor Cars

DID YOU KNOW THAT YOUR FRONT WHEELS AND TIRES COULD COME OFF YOUR 1984 -1985 AVANTI ?

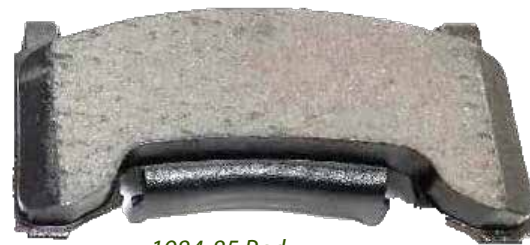
1963-83 Pad

The 1984 system did indeed stop better as the friction surface of the front brake pads was about 2-1/2 to 3 times that of the friction surface on the 1963-1983 pads.

1984-85 Pad

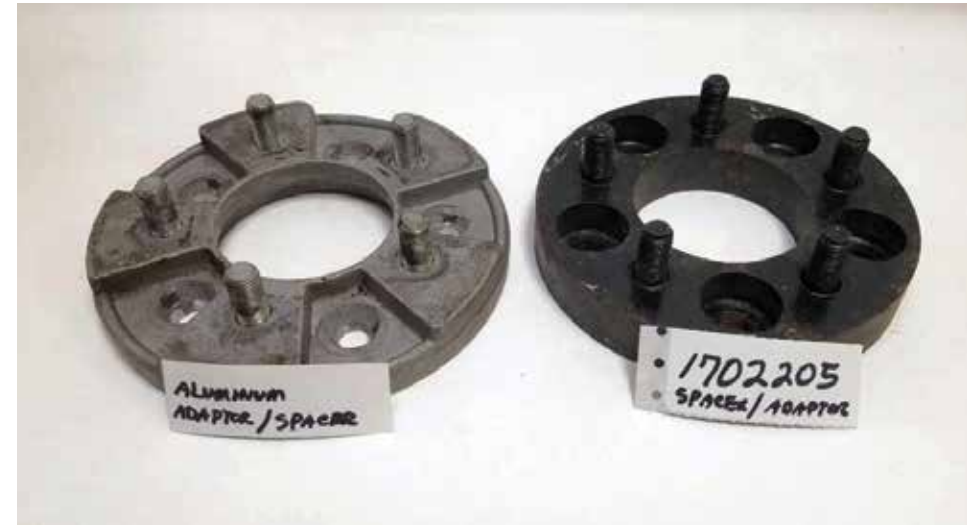
These one inch spacer adapters were made out of aluminum and they were breaking. The front tire and wheels were coming off as a person was driving the car.

About 15 years ago I had a 1984 Avanti delivered on a flat bed tow truck. The left front wheel aluminum spacer/adaptor had broke and the left front wheel and tire came off. The five lug nuts were still attached to the wheel.

Apparently there are still 1984, and possibly 1985 Avantis with the aluminum spacer adapters. About a year ago I sold a bunch of N.O.S. 1984 Avanti parts for a 1984 Avanti that the left front wheel came off because the aluminum spacer adaptor broke. This car had a lot of body and suspension damage. This is just a partial list of the parts I supplied:

- Left Front Fender
- Front Bumper
- Rotor & Bearings & Etc.
- Brakes
- Lower Control Arm with All Busings
- Upper Control arm with All Bushings
- Front 1" Sway Bar & Brackets
- Wheel & Etc.
- And of course a pair of N.O.S. Steel 1702205 Spacer Adaptors.

The factory called me to inform me of this problem. They were having new spacers/adapters made up in steel. Part #1702205. I placed my order for the new one inch steel spacer/adapters. The factory asked me to change them on my new 1984 Avantis, I had in stock and the ones I had sold. They also instructed me to pull both front wheels off all 1984 Avantis that came in for service and change the adapters to the steel ones. I was also instructed to tell the customer that I had changed them as the aluminum spacer adapters could break and Avanti Motors was paying the bill.

I hope you take this article as a opportunity to pull both front wheels on your 1984-1985 Avanti and take a magnet to the spacer adaptor. Of course the magnet won't stick to aluminum, and that is the easiest way to determine what you have.

If you have the steel spacer adapters, you might want to remove all five lug nuts that holds the adaptor to the rotor and put red Loctite on the threads. Just maybe when or if somebody has installed new rotor they may have not put the Loctite on the threads.
